IMPOUNDMENT SHORELINE CHARACTERIZATION STUDY

WEST CANADA CREEK HYDROELECTRIC PROJECT
FERC No. 2701-NY

March 2020

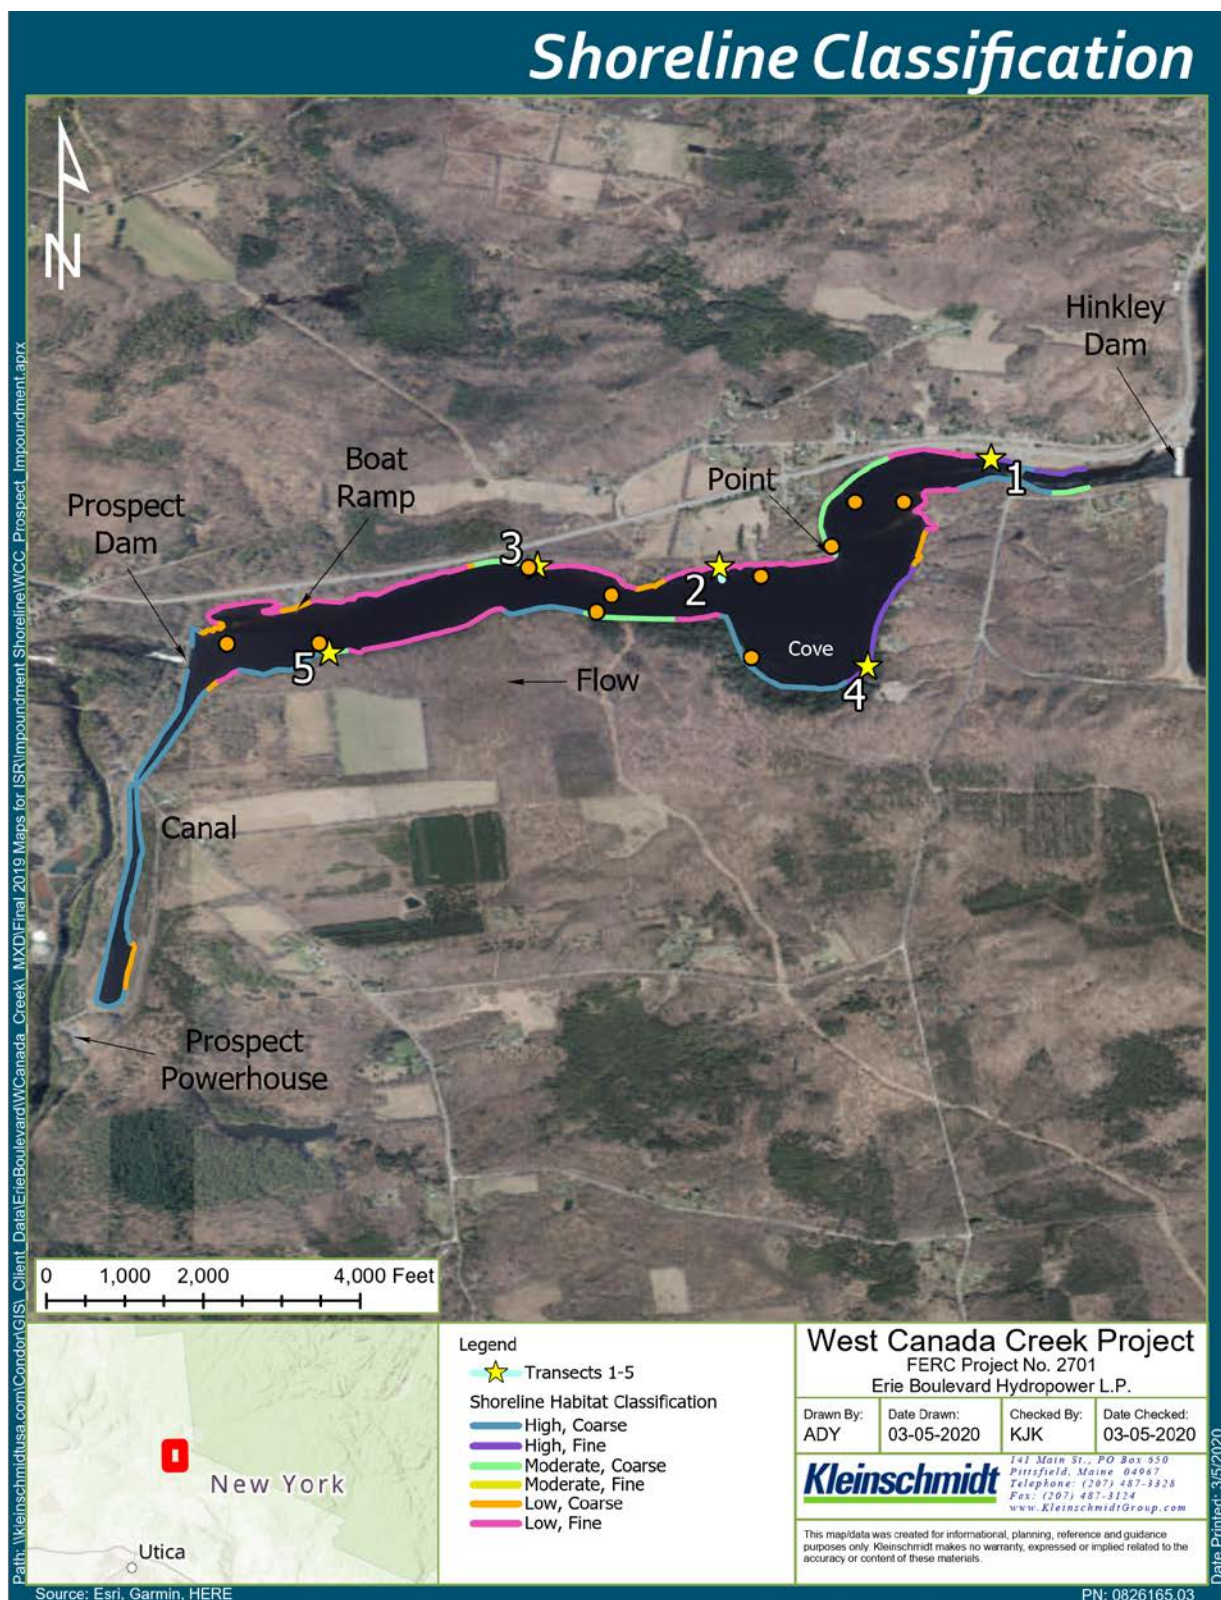
FIGURE 3-1 PROSPECT IMPOUNDMENT HABITAT DISTRIBUTION AND LOCATION OF MICROHABITAT TRANSECTS

Figure 3-1 depicts the distribution of the 6 identified habitat categories. Each habitat classification was mapped around the nearly 6-mile perimeter of the impoundment and canal. Table 3-2 lists the linear distance and relative proportion of each habitat classification. Habitat within the canal was separated from the impoundment habitat due to the unique armored banks spanning both sides of the canal. The canal consisted of 1.2 miles (91 percent) of steep banks armored with cobble riprap, with a small 615-foot section within the forebay of low gradient slope habitat (Figure 3-1, Table 3-2).

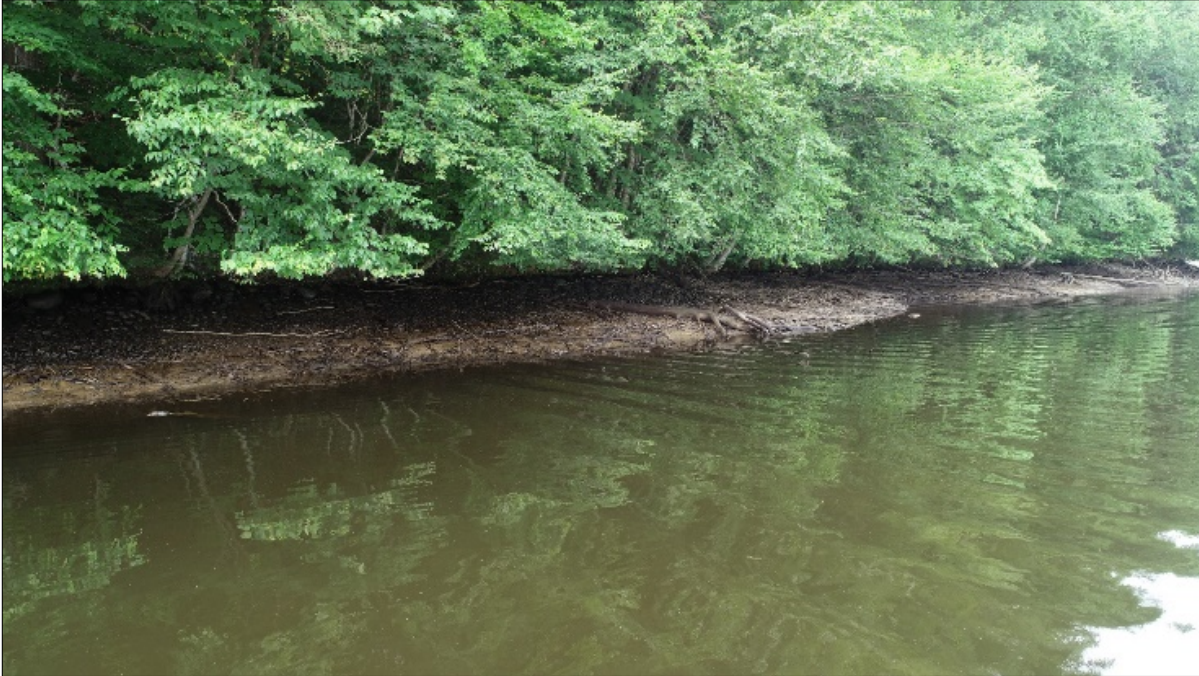
PHOTO 3-1 PROSPECT IMPOUNDMENT SHORELINE HABITAT WITH HIGH GRADIENT SLOPE

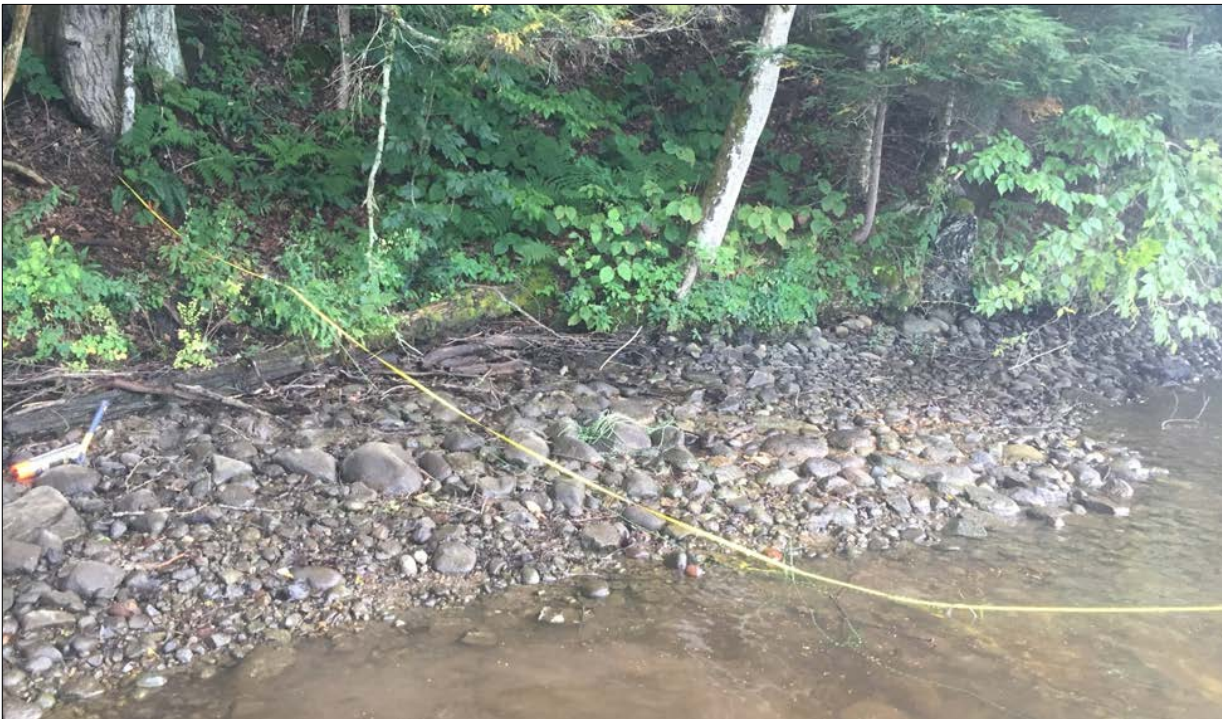
PHOTO 3-2 PROSPECT IMPOUNDMENT SOUTHERN SHORELINE APPROXIMATELY 1,500 FEET UPSTREAM OF THE PROSPECT DAM

Note: Transect represents habitat with a moderate gradient slope and coarse substrate.

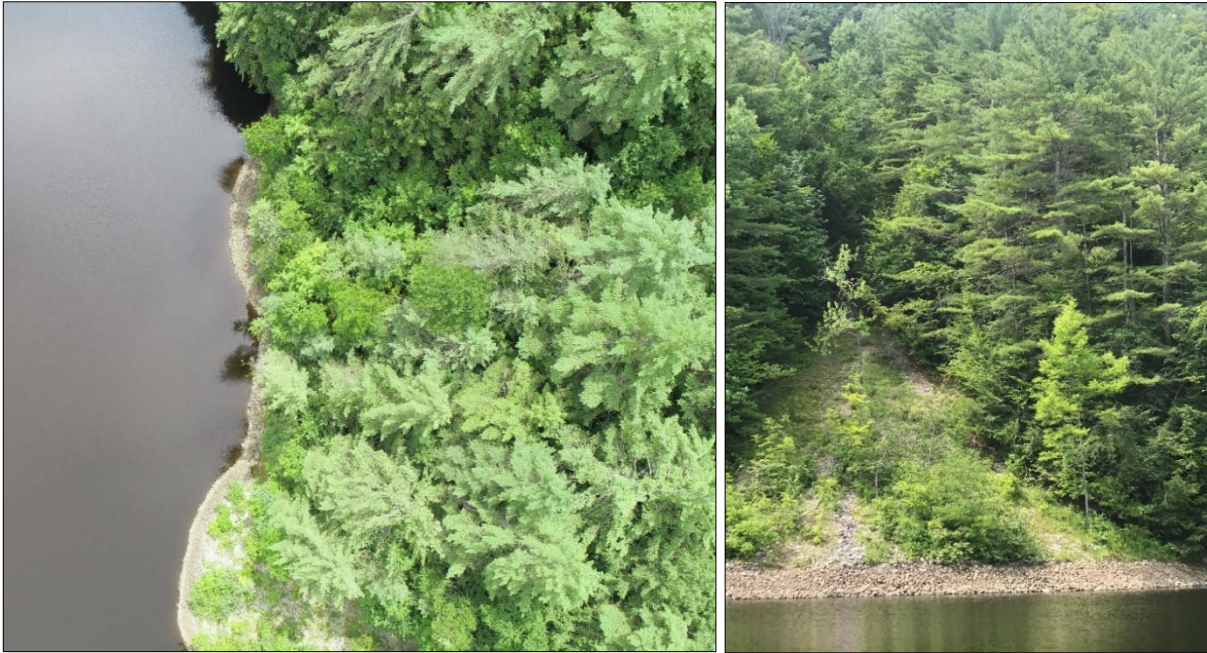
Overall, the two most predominant littoral habitat types within the Prospect impoundment included fine sediment substrates of low gradient slope (45 percent) and coarse substrates of high gradient slope (31 percent) (Table 3-2). In the impoundment, high gradient, coarse substrate habitat is largely confined to the southern shore where steep topography extends into the impoundment. Aquatic vegetation was absent in areas with a high gradient and coarse substrate, likely due to the minimal area occurring within the photic zone and poor rooting substrate. Given the steep slope of the littoral bed, relatively little habitat is exposed in these areas when the pond elevation is drawn down (Photo 3-1 and Photo 3-2, see Figure 3-2 for location of representative photos). Within the cove area, the upland and riparian zones are extremely steep and transition into a high gradient littoral zone. Erosion was observed above the influence of the impoundment fluctuation zone in the steep upland zone, depositing sand, gravel and small cobble, as well as organic materials into the impoundment (Photo 3-3).

PHOTO 3-3 EROSION ALONG PROSPECT IMPOUNDMENT WITHIN THE COVE AREA
Note: the erosion originates from an upland area above the influence of the impoundment.

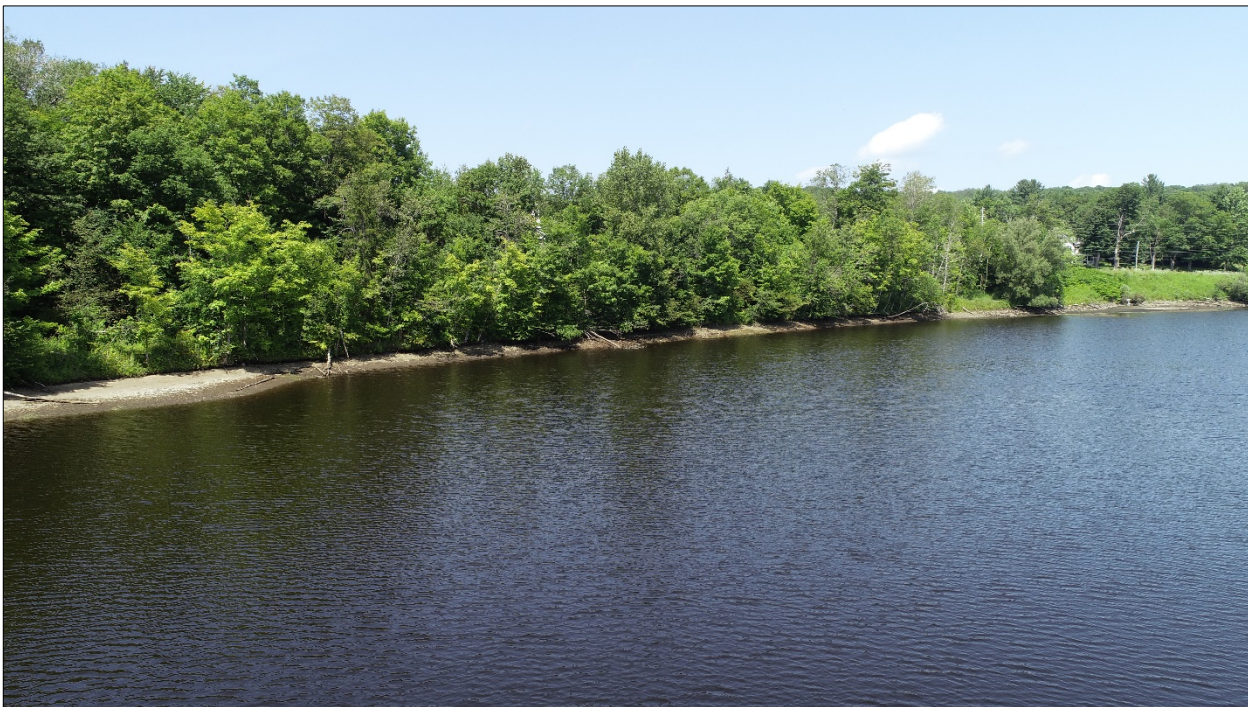
PHOTO 3-4 PROSPECT IMPOUNDMENT NORTH SHORELINE APPROXIMATELY 2,700 FEET DOWNSTREAM OF HINCKLEY DAM
Note: Represents habitat with moderate slope with fine substrate

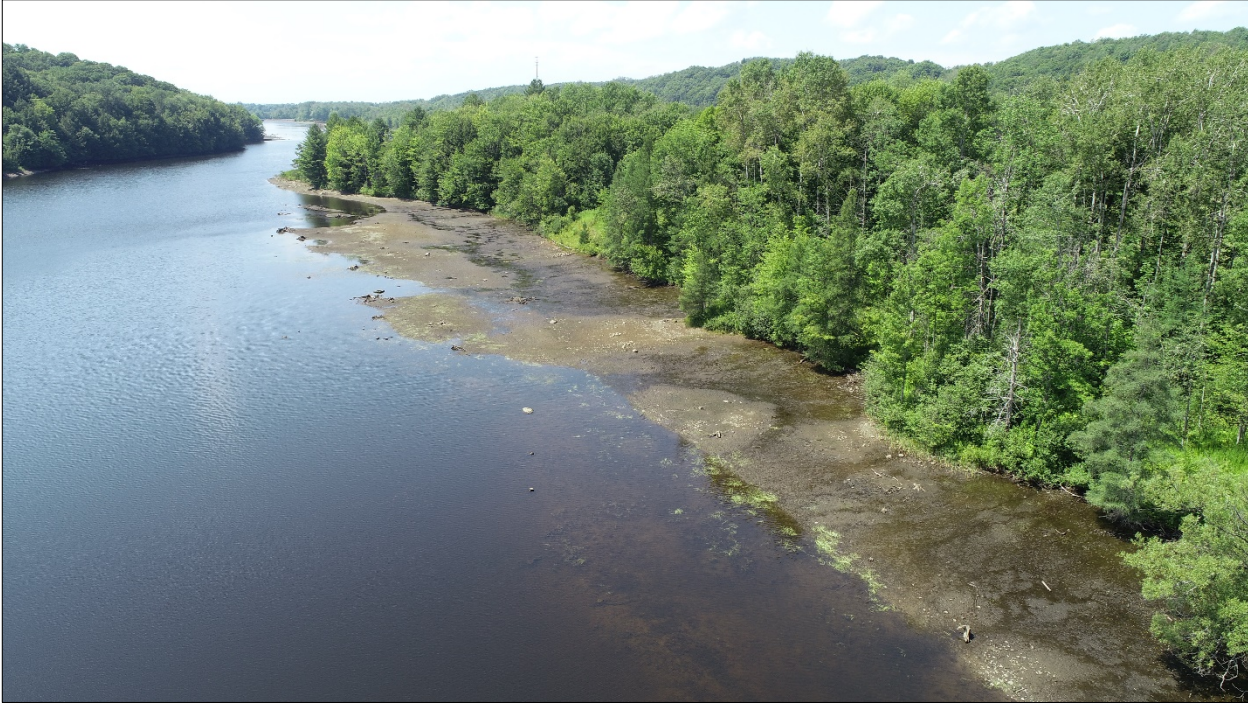
PHOTO 3-5 PROSPECT IMPOUNDMENT NORTH SHORE REPRESENTING HABITAT WITH LOW GRADIENT SLOPE AND FINE SUBSTRATE

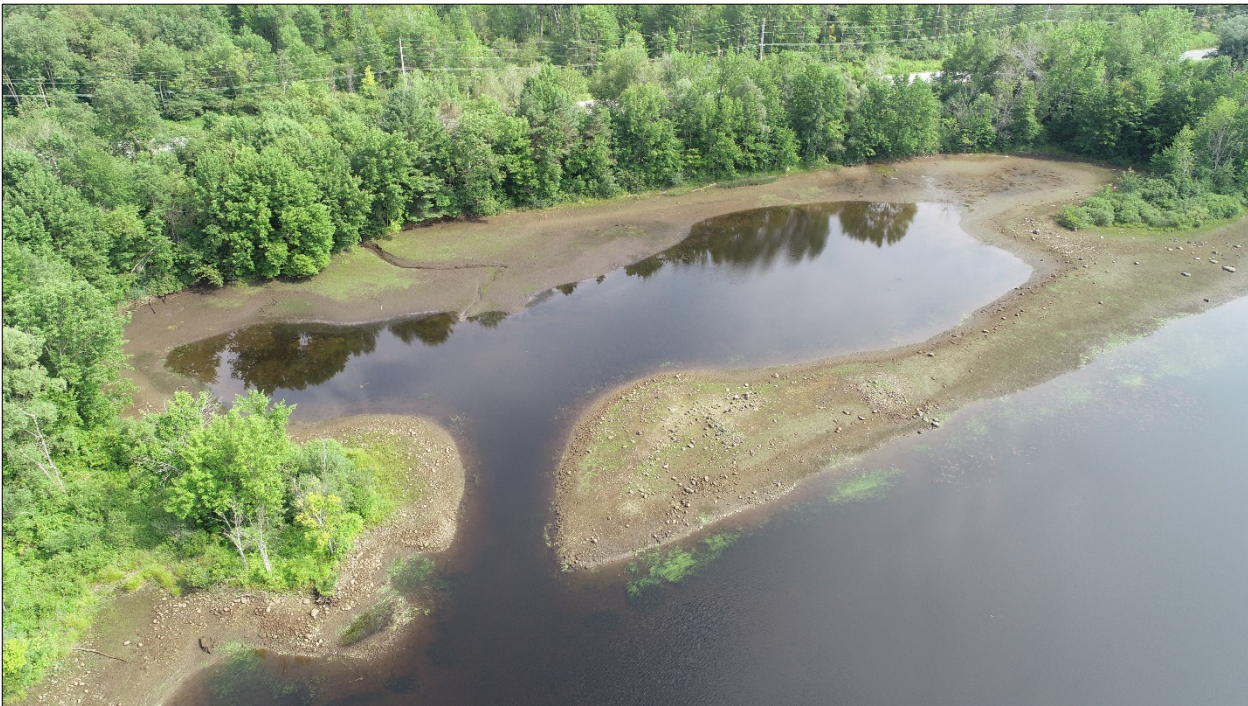
The northern shore consists predominately of low to moderate gradient littoral zones, except for a stretch of high gradient fine substrate habitat extending from Hinckley dam to approximately 2,000 feet downstream. At this point, a low gradient littoral bed transitions into a moderate gradient, coarse substrate habitat that stretches along the outside bend of the S-curve (Photo 3-4). Around the point, where the impoundment widens to the deep cove, the littoral slope lessens as the habitat transitions into a low gradient reach with fine substrates. This area forms a mud flat that is exposed when the impoundment is drawn down to minimum pond elevation (Photo 3-5). This mud flat extends approximately 1 mile from the point to the Prospect boat launch, where coarse substrate has been placed for armament at the boat ramp. A small shallow cove with fine substrates is located a short distance downstream of the boat ramp. The cove is formed by a peninsula of coarse substrates that is exposed at low pond elevations. A deep cut (approximately 6 feet deep at low pond) at the southern extent of the cove connects the small cove to the impoundment at minimum pond elevation (Photo 3-6).

PHOTO 3-6 PROSPECT IMPOUNDMENT NORTH SHORE SMALL COVE WITH OUTLET LOCATED DOWNSTREAM OF THE BOAT RAMP

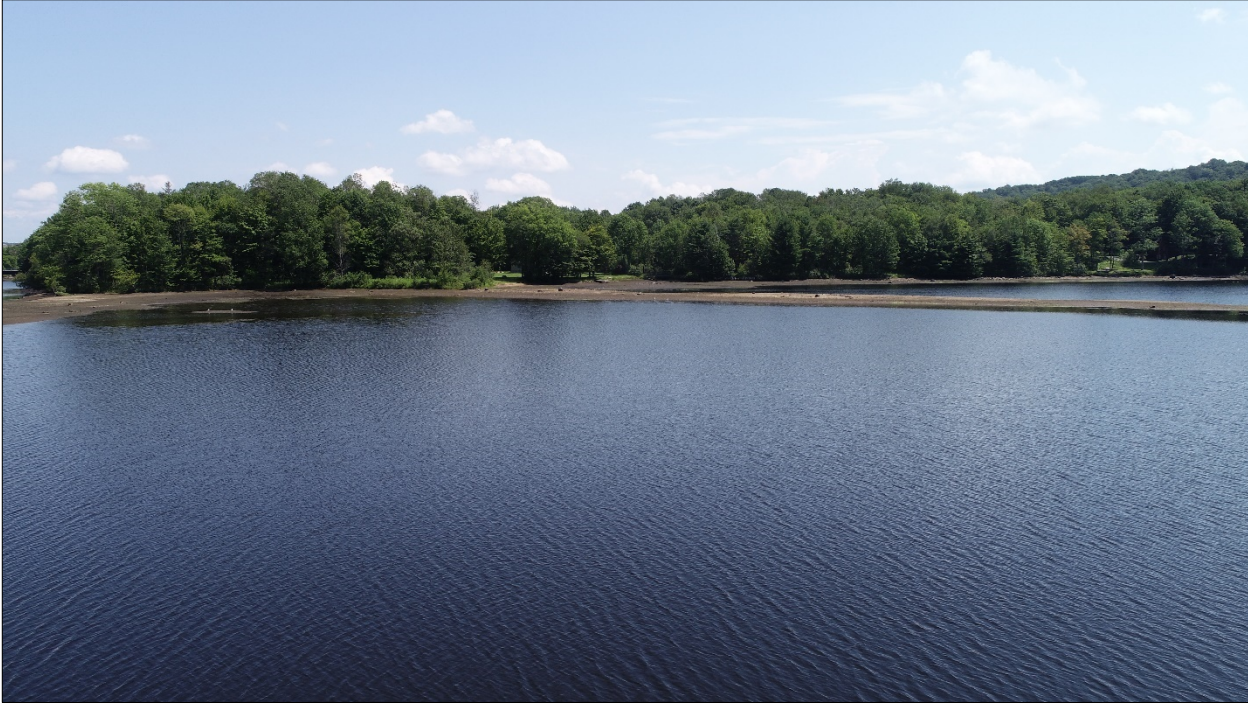
Another fine sediment flat is located on the inside bend downstream of the Hinckley dam. This flat is formed by sediment deposited from the slower moving water that sweeps around the bend in the impoundment as the river widens. The deposited sediments form two peninsulas that are exposed at low pond elevation (Photo 3-7). The longest peninsula, slightly downstream from the first, is formed by an old railroad bed, for which an old bridge buttress is evident between the peninsula and the north shore (Photo 3-8). The area around these sediment deposits is one of the few stretches along the southern shore that contains a low gradient, fine substrate habitat.

PHOTO 3-7 SEDIMENT DEPOSIT PENINSULAS DOWNSTREAM OF HINCKLEY DAM

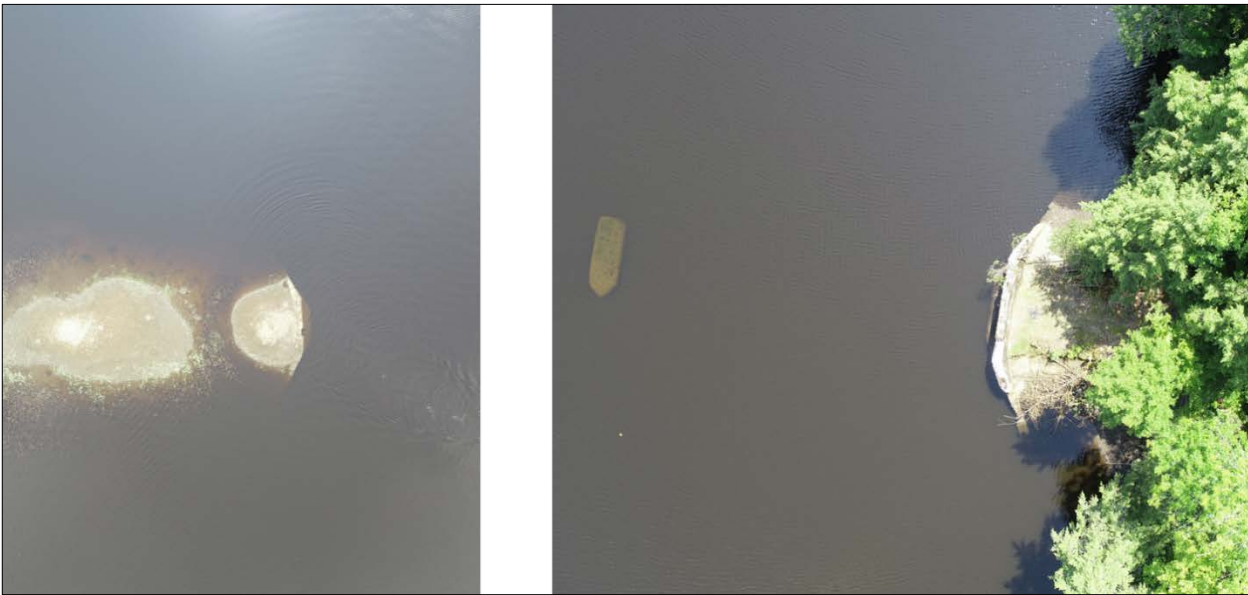
PHOTO 3-8 PROSPECT IMPOUNDMENT SEDIMENT DEPOSIT AT ABANDONED RAILROAD BED

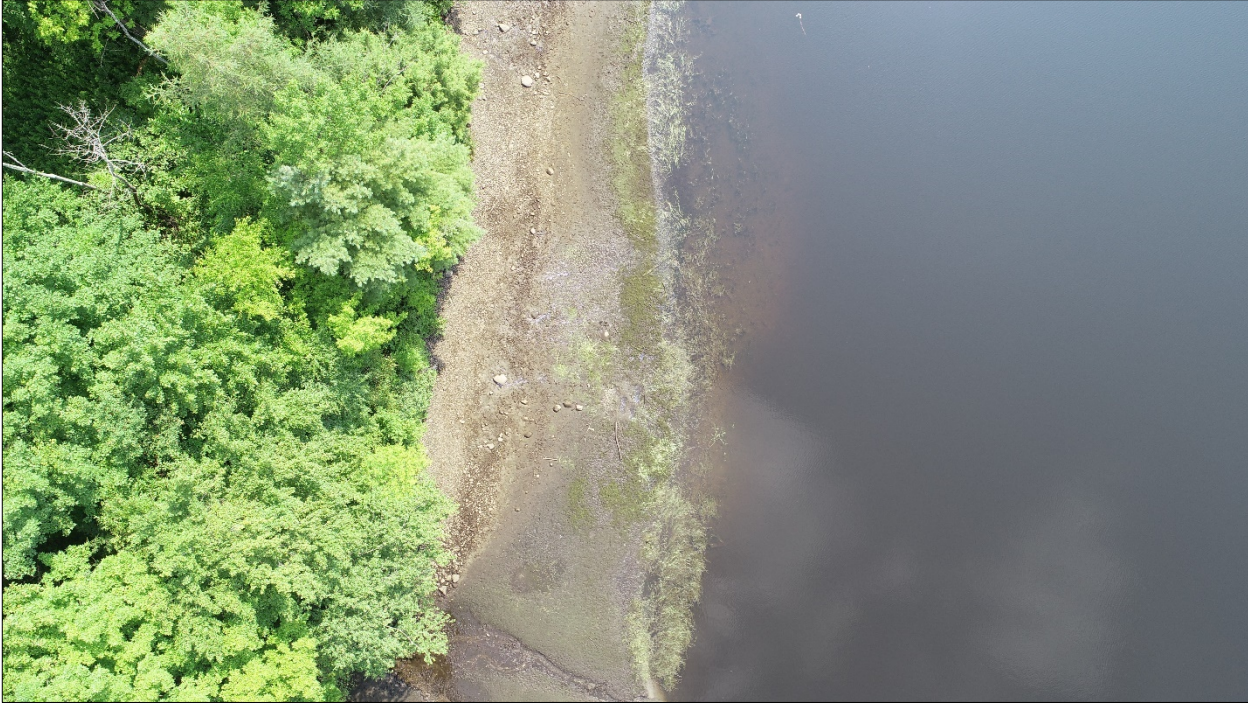
Submerged aquatic vegetation (SAV) beds were widespread within the impoundment. Most SAV occurred in areas of low gradient slope with fine substrates suitable for rooting. SAV was most dense near the minimum pond elevation and decreased in density as depth increased or substrates became unsuitable for rooting (Photo 3-9). Phragmites were the only documented emergent aquatic vegetation (Photo 3-10).

PHOTO 3-9 PROSPECT IMPOUNDMENT SUBMERGED AQUATIC VEGETATION IN LOW GRADIENT HABITAT WITH FINE SUBSTRATE APPROXIMATELY 2,000 FEET UPSTREAM OF THE BOAT RAMP

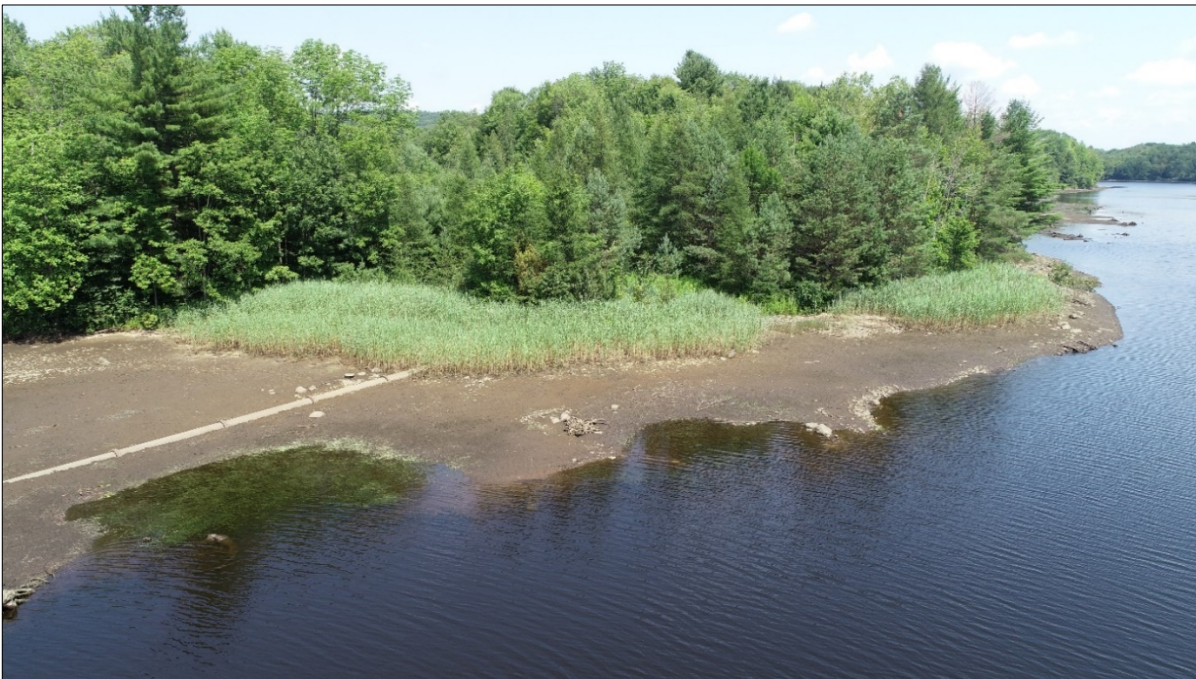
PHOTO 3-10 PROSPECT IMPOUNDMENT SHORELINE PHRAGMITES STAND

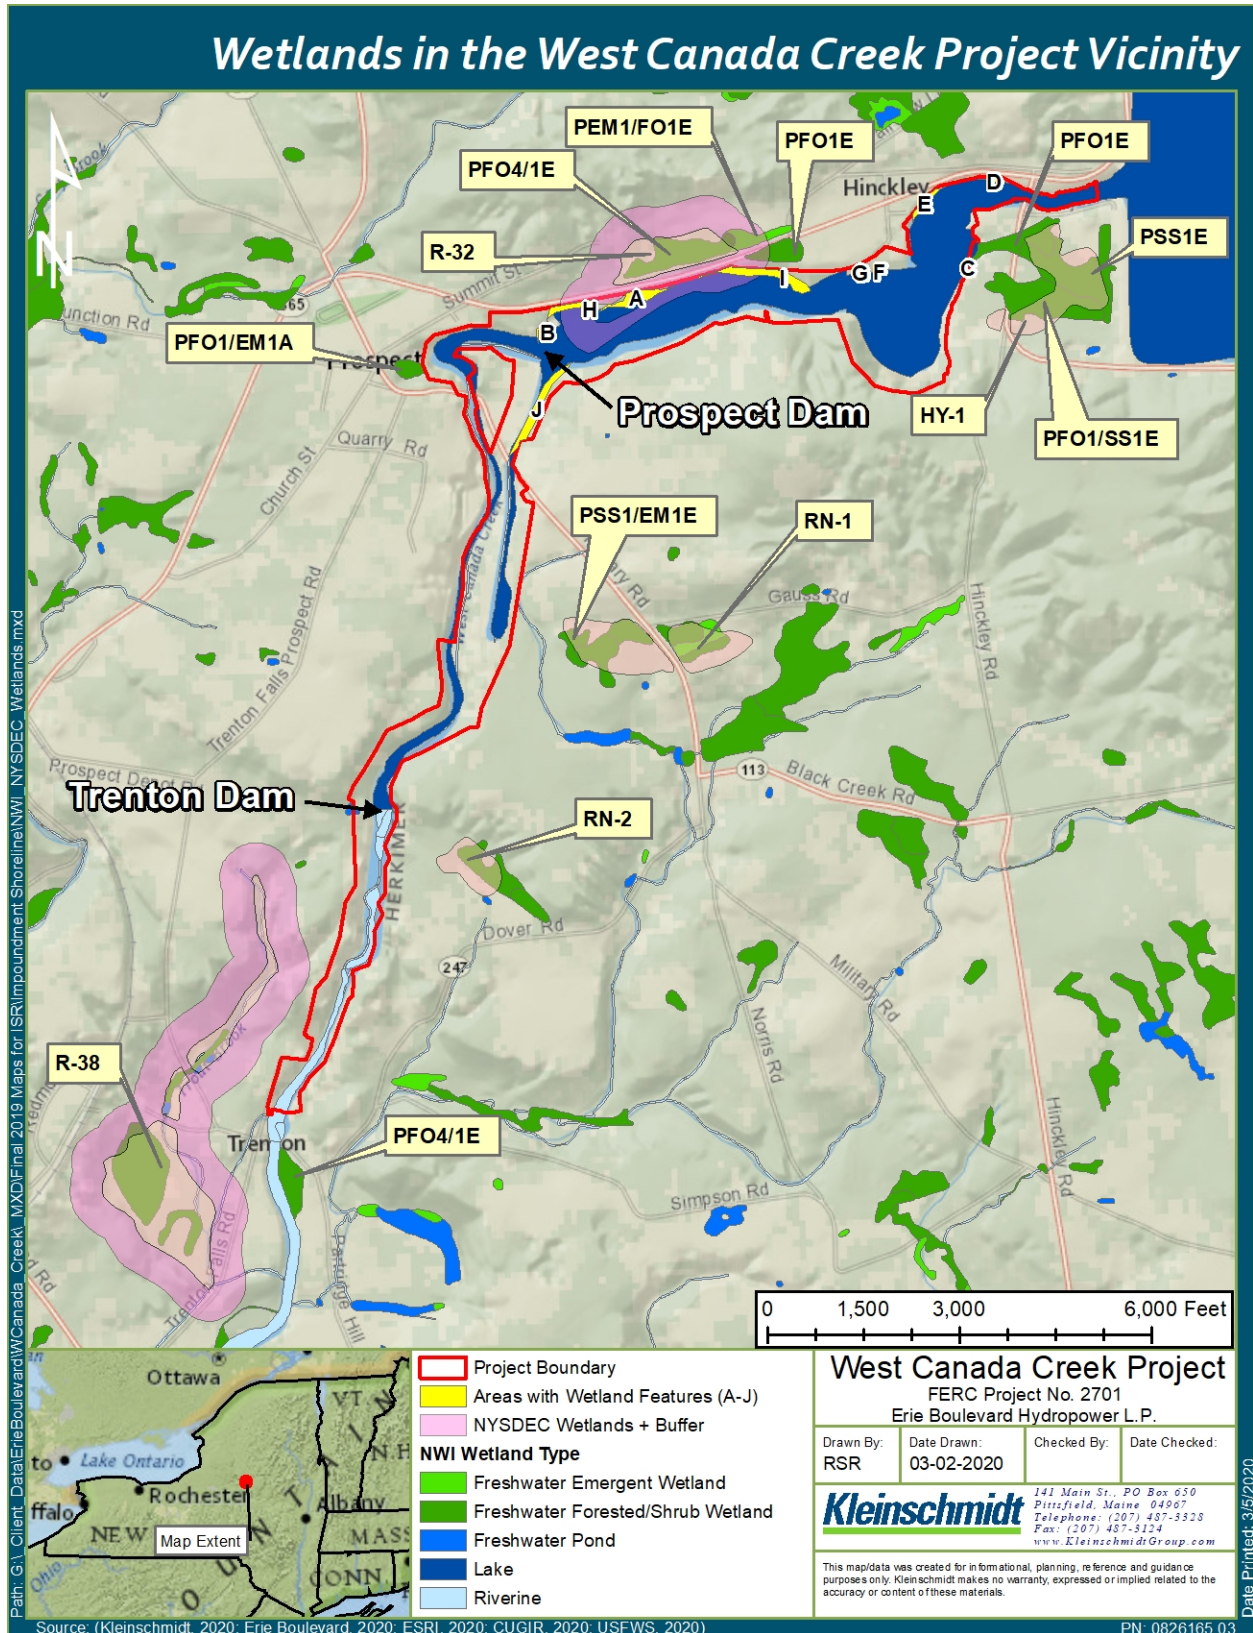
FIGURE 3-3 NWI AND NYSDEC IDENTIFIED WETLANDS AND AREAS WITH WETLAND FEATURES NEAR THE WEST CANADA CREEK PROJECT

Wetlands within the Prospect impoundment boundary were mapped from the NWI and NYSDEC wetland data and verified by drone imagery. The NWI database (USFWS, 2020) identifies one wetland feature within the Project boundary, and eight NWI identified wetland features within the general vicinity of the Project boundary (Table 3-3 and Figure 3-3). The NYSDEC regulated wetlands within the general vicinity of the Project include five wetlands (R-32 – Class 2, 29.4 acres, HY-1 – Class 3, 35.2 acres, RN-2, Class 3, 13.9 acres, RN-1- Class 3 – 44 acres, and R-38, Class 4, 86.6 acres) encompassing a total of 209.1 acres (CUGIR 2020; NYSDEC 2020) (Figure 3-3). Ten (10) separate areas with wetland features were documented along the perimeter of the Prospect impoundment and power canal (Figure 3-3).

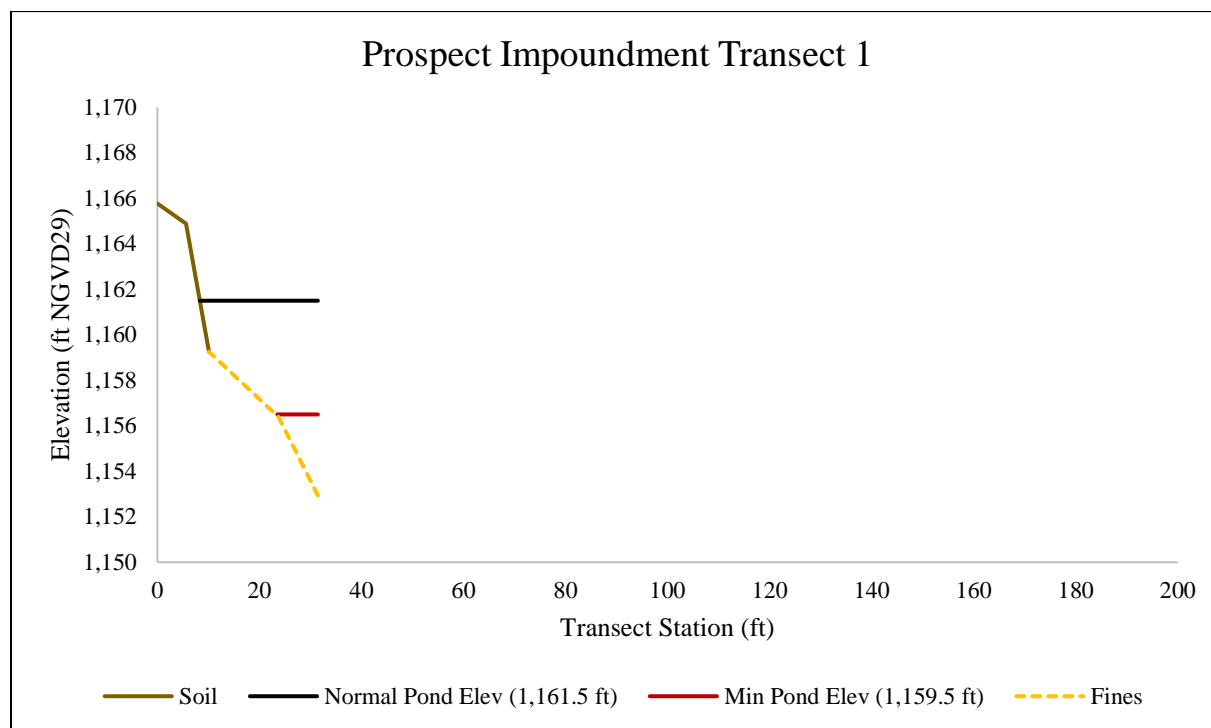
FIGURE 3-4 CROSS SECTION OF TRANSECT 1 IN THE PROSPECT IMPOUNDMENT

A total of 5 transects were surveyed within the Prospect impoundment on August 20 and 22, 2019 (Figure 3-1, Table 3-4). During the microhabitat survey, pond elevation averaged 1,160.2 feet on August 20 between 11:00 and 19:00, and 1,159.2 feet on August 22 from 15:00 to 18:00. Transects varied in length from 31 feet (Transect 1) up to 196 feet (Transect 2), depending on the steepness of the slope between the headpin and the point where bed elevation reaches 3 feet below the minimum water elevation. Longer transects were required to traverse horizontal flats in areas with a low gradient slope. Table 3-4 provides coordinates for each transect headpin, the transect slope, length, and information describing the habitat each transect represents. Transect cross-sections are depicted in Figure 3-4 through Figure 3-8, with corresponding photos of each transect.

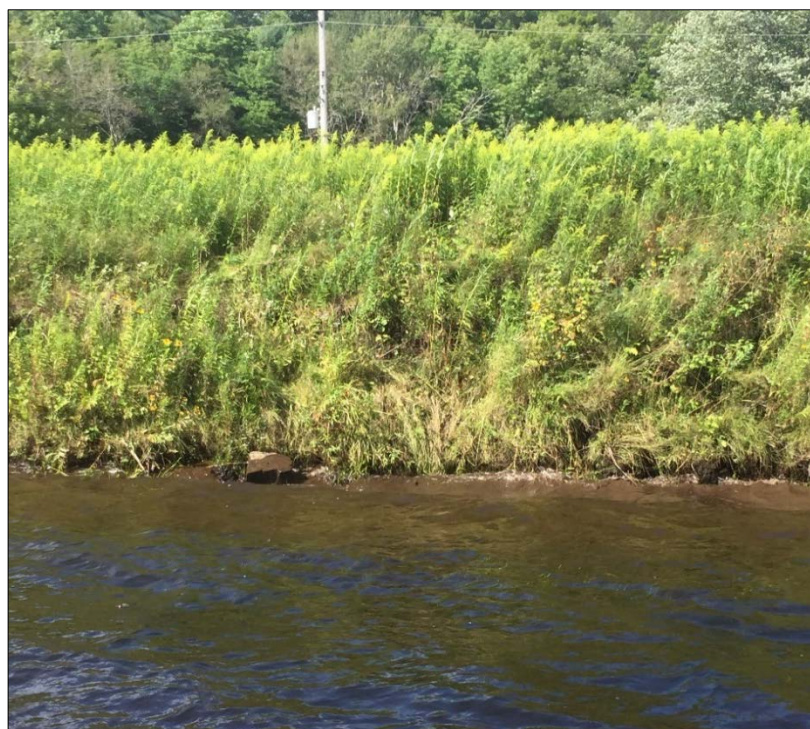
PHOTO 3-11 PROSPECT TRANSECT 1 REPRESENTING HABITAT WITH HIGH GRADIENT SLOPE AND FINE SUBSTRATES

Note: SAV was present. The shoreline at this site is in close proximity to a road alignment where shoreline vegetation is maintained.

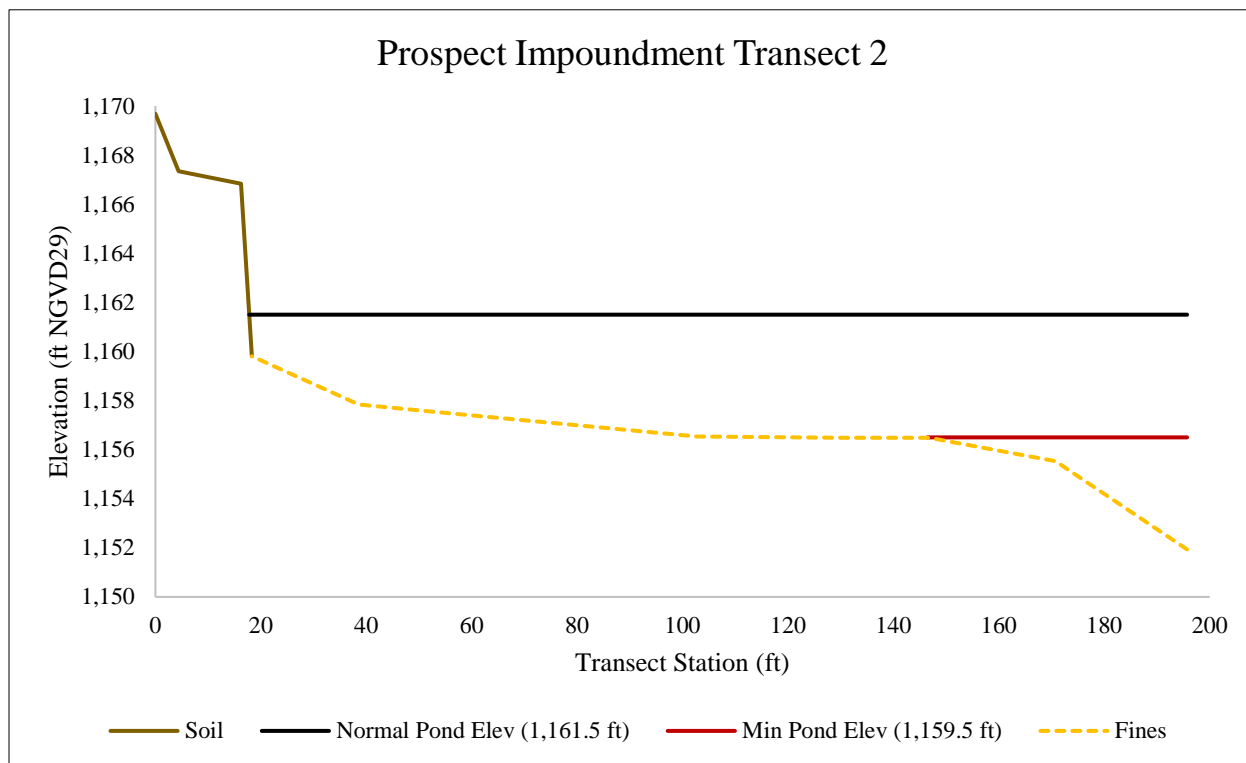
FIGURE 3-5 CROSS SECTION OF TRANSECT 2 IN THE PROSPECT IMPOUNDMENT

Transect 2, representing very low gradient habitat, resulted in the most habitat exposed at minimum pond elevation (129 feet), exposing exclusively fine substrate. SAV beds, woody debris, and root wads provided cover in this shallow area. Although expanses of this habitat were exposed at minimum pond elevation, dense SAV beds below this elevation remain watered and provide adequate habitat cover.

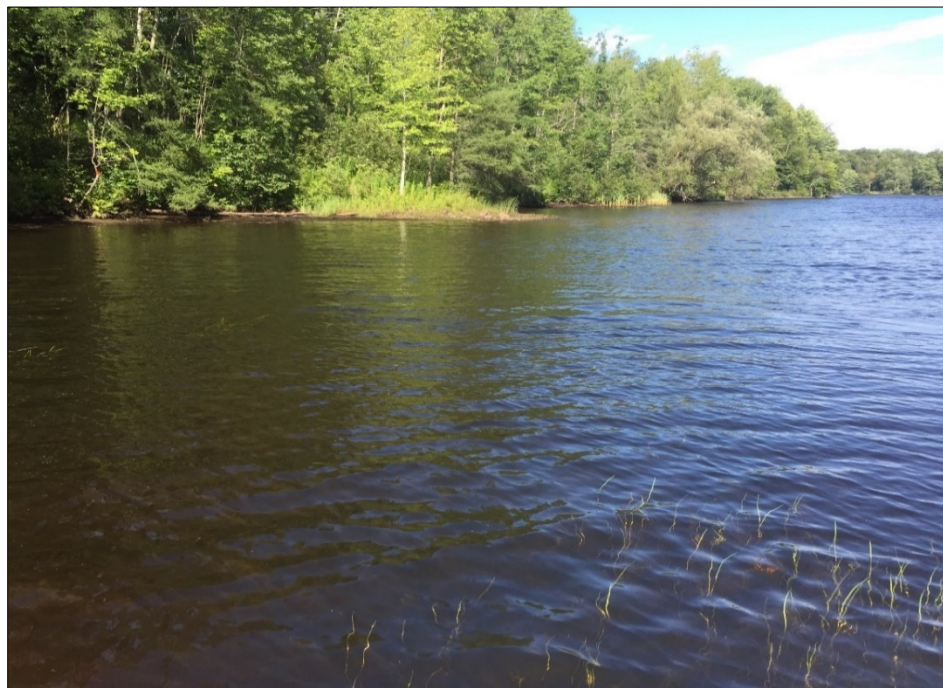
PHOTO 3-12 PROSPECT TRANSECT 2 REPRESENTING HABITAT WITH LOW GRADIENT SLOPE AND FINE SUBSTRATE

Note: SAV was present.

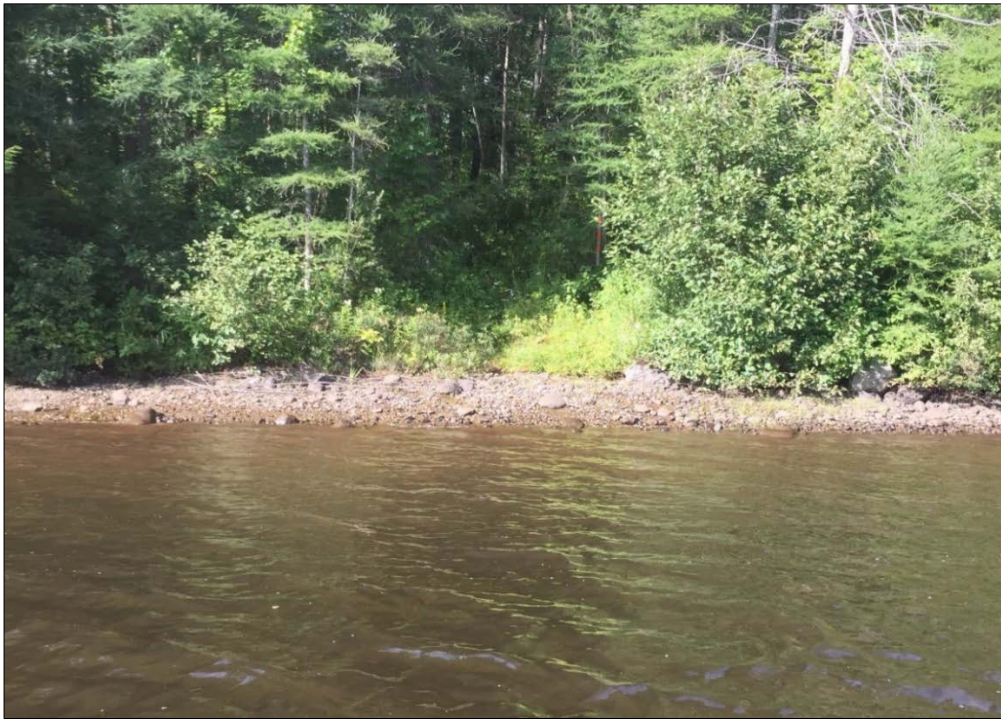
PHOTO 3-13 PROSPECT TRANSECT 3 REPRESENTING HABITAT WITH MODERATE GRADIENT WITH COARSE SUBSTRATE

Note: Fine substrate with SAV was observed below the normal pond elevation seen here.

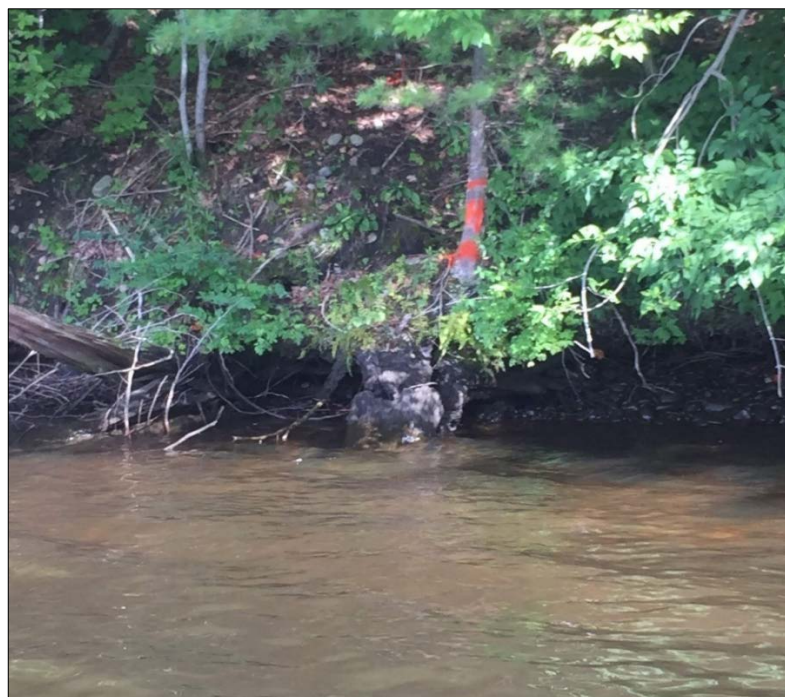
PHOTO 3-14 PROSPECT TRANSECT 4 REPRESENTING HABITAT WITH HIGH GRADIENT SLOPE AND FINE SUBSTRATE

Note: Fine substrate and large woody debris observed below the normal pond elevation seen here.

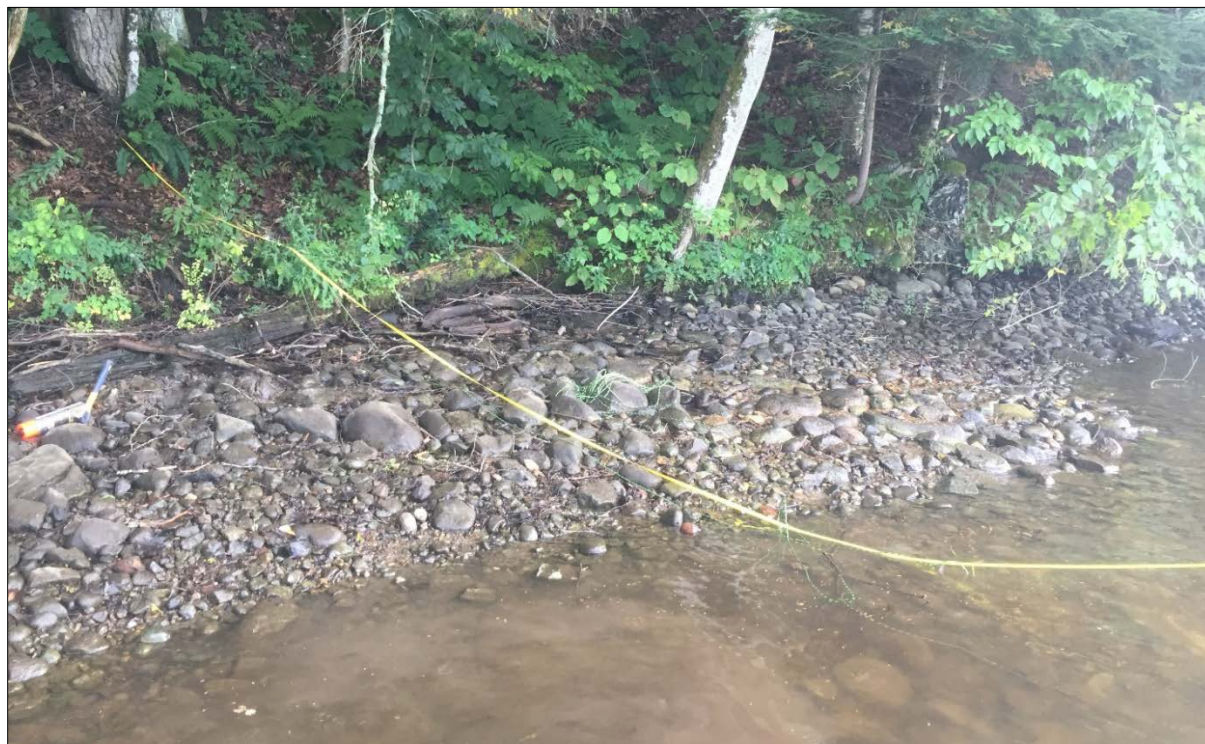
PHOTO 3-15 PROSPECT TRANSECT 5 REPRESENTING HABITAT WITH MODERATE GRADIENT SLOPE AND COARSE SUBSTRATE.

Note: SAV was present in low density.

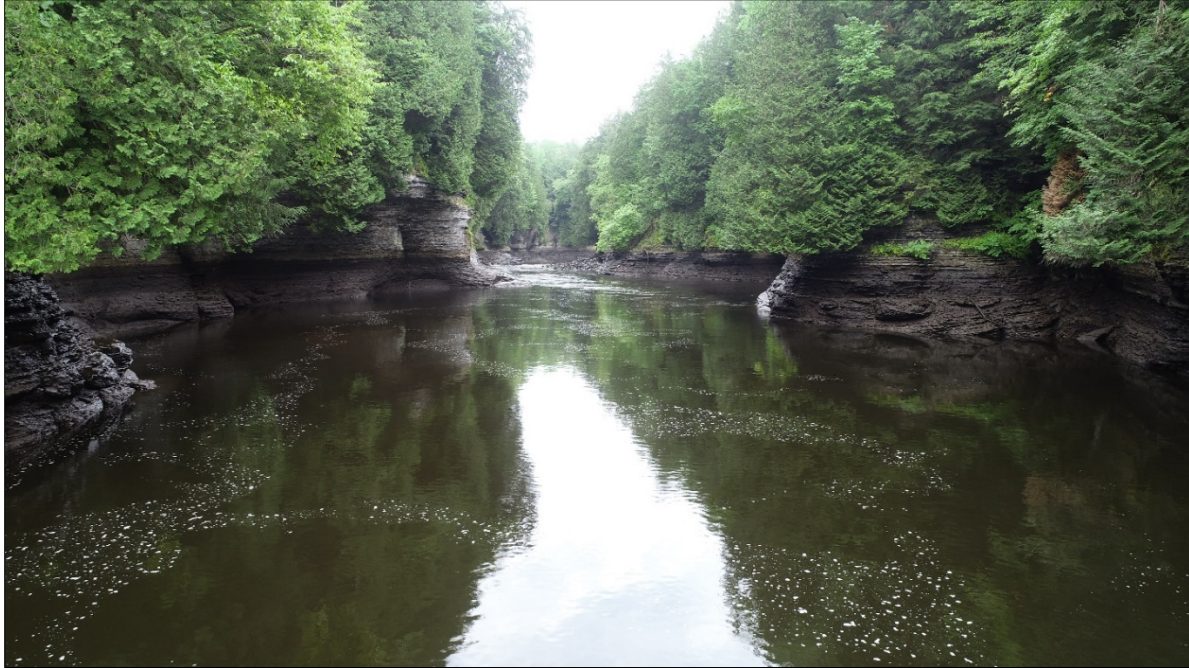
Littoral habitat within the Trenton impoundment is largely uniform with shoreline areas consisting of high, nearly vertical bedrock walls that form a narrow gorge along the length of the impoundment (Photo 3-16). The nearly vertical gorge walls flank the impoundment and extend below the water surface resulting in minimal littoral habitat except in a few areas containing boulder and cobble deposits (Photo 3-17). Boulder and cobble deposits were mostly found in small patches adjacent to indentations in the gorge wall or along the inside bend in the channel, where slower moving waters would deposit coarse sediment and substrate.

PHOTO 3-16 TRENTON IMPOUNDMENT BEDROCK GORGE

Note: For Location see Figure 3-9, Photo A.

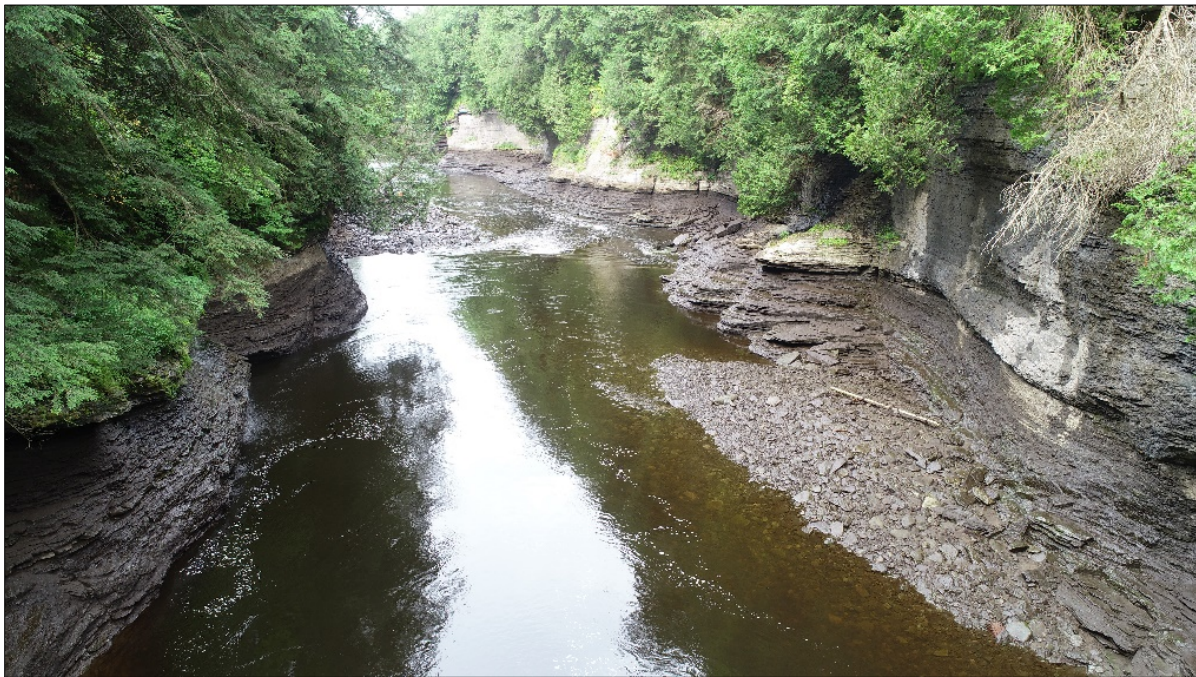
PHOTO 3-17 TRENTON IMPOUNDMENT BOULDER AND COBBLE DEPOSITS

Note: For location, see Figure 3-9, Photo B.

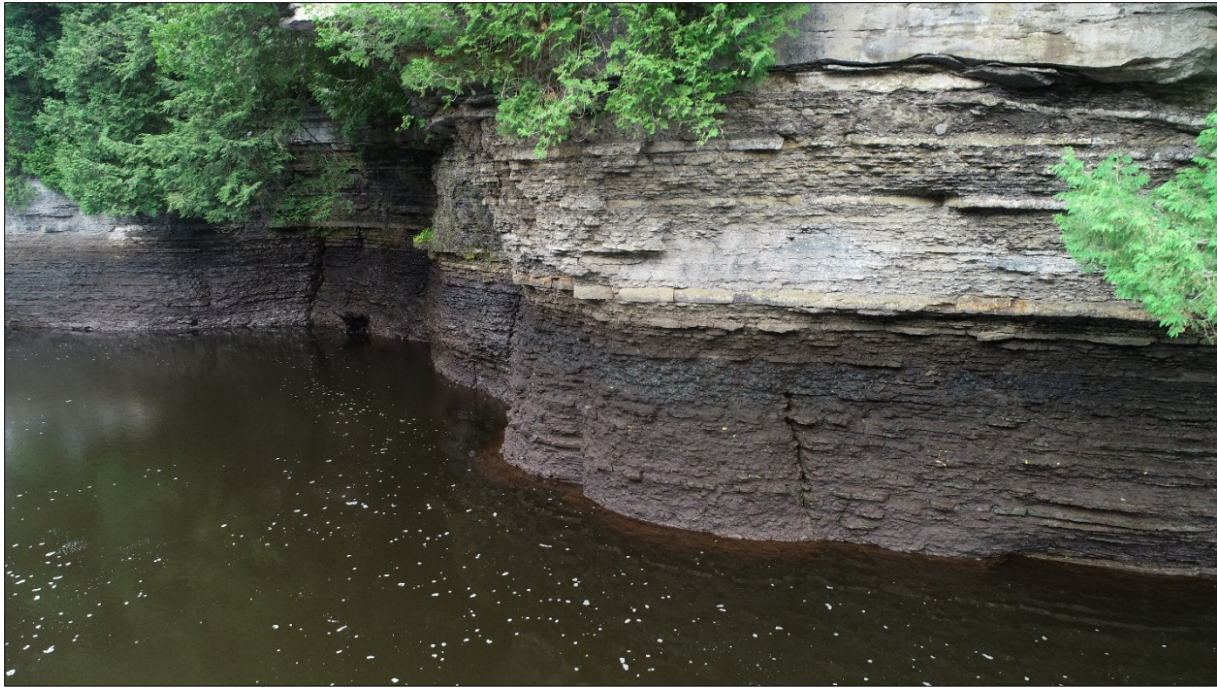
PHOTO A-1 LOWER TRENTON IMPOUNDMENT SHORELINE
