IMPOUNDMENT SHORELINE CHARACTERIZATION STUDY

WEST CANADA CREEK HYDROELECTRIC PROJECT
FERC No. 2701-NY

March 2020

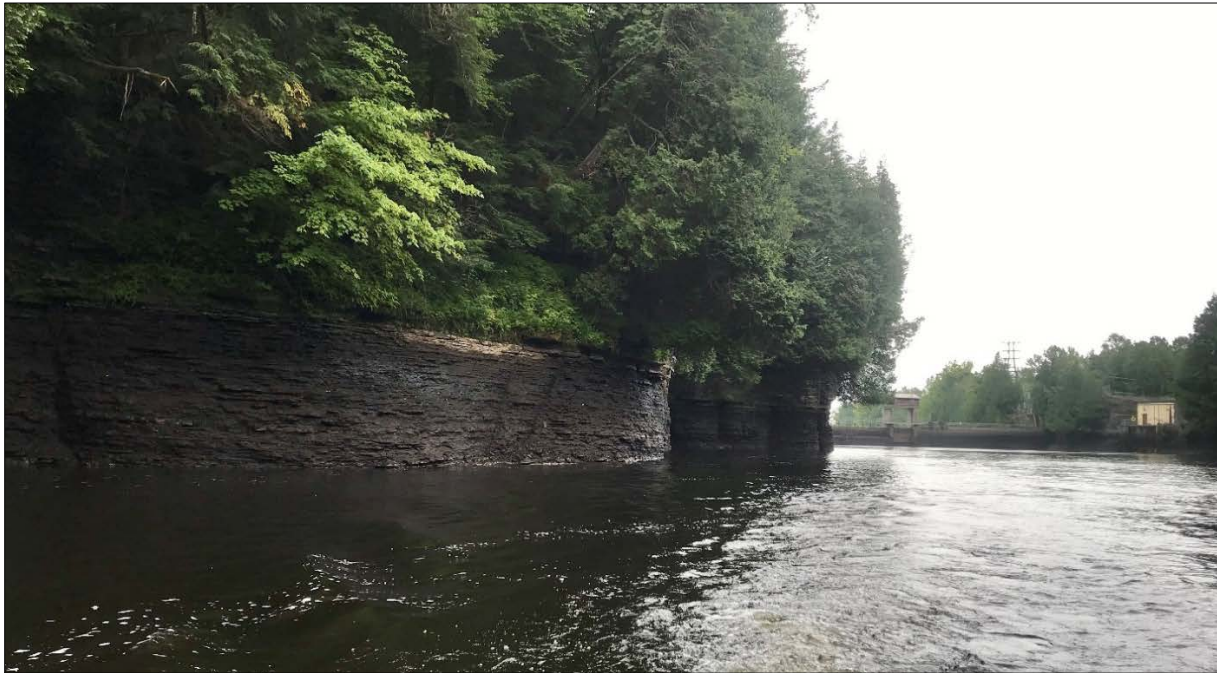
PHOTO A-2 LOWER TRENTON IMPOUNDMENT LOOKING DOWNSTREAM TOWARDS DAM

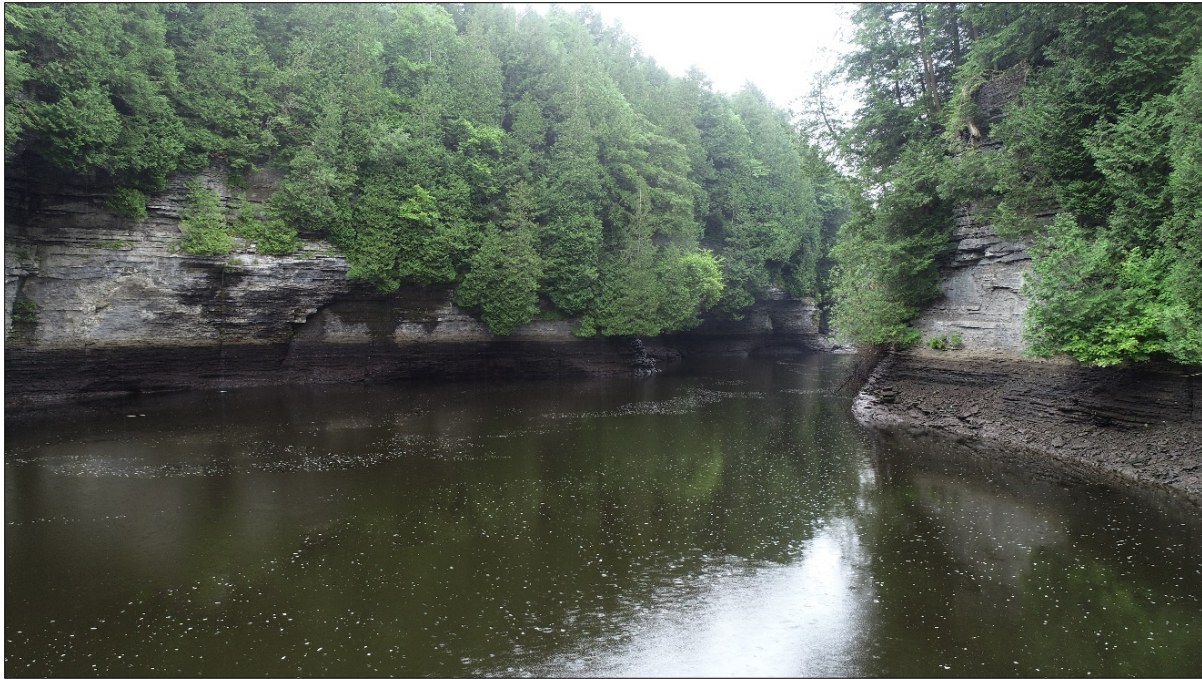
PHOTO A-3 LOWER SECTION OF TRENTON IMPOUNDMENT

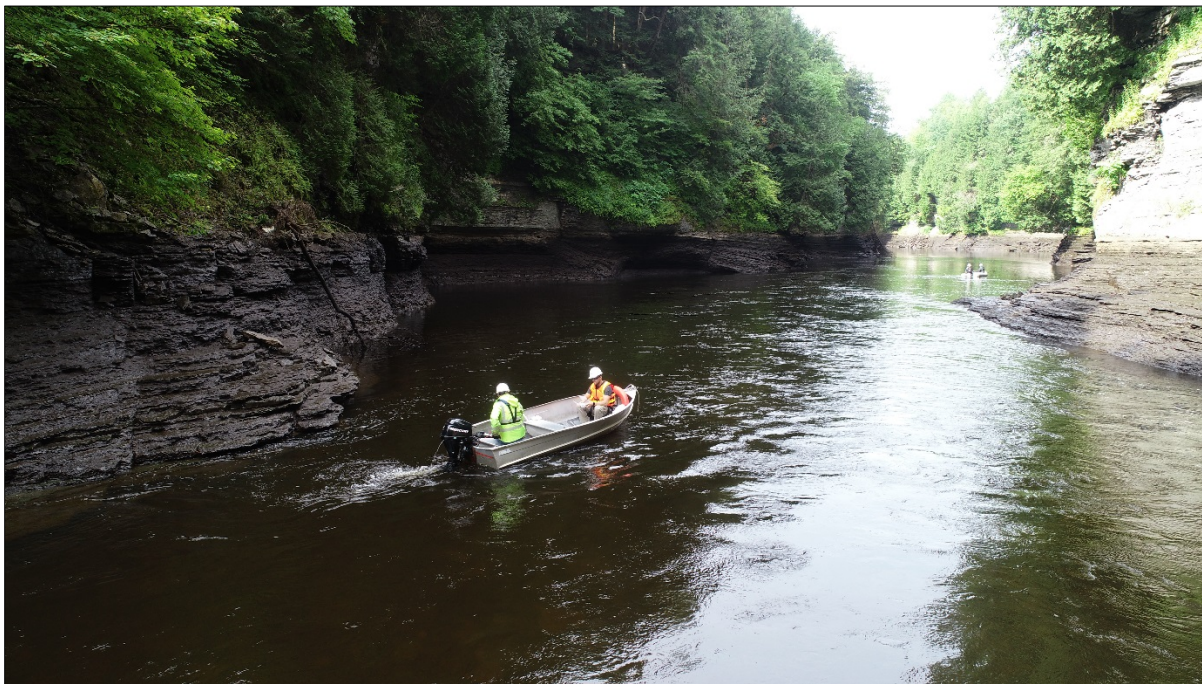
PHOTO A-4 MIDDLE SECTION OF TRENTON IMPOUNDMENT

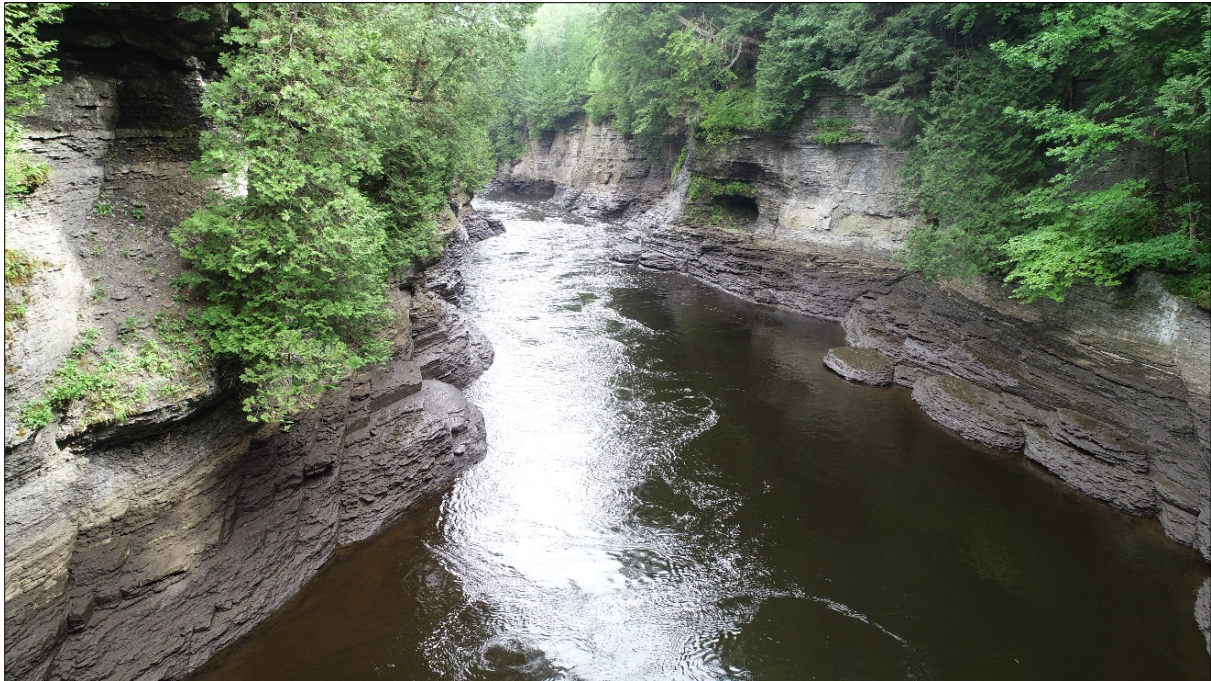
PHOTO A-5 MIDDLE SECTION OF TRENTON IMPOUNDMENT

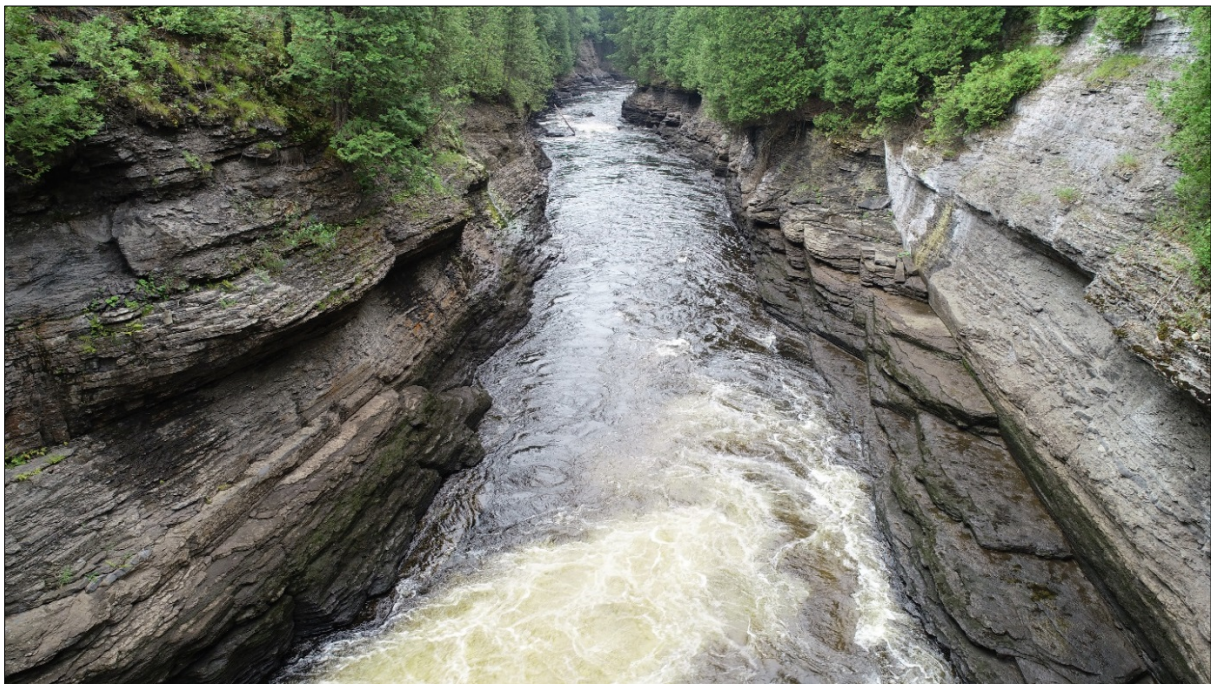
PHOTO A-6 UPPER TRENTON IMPOUNDMENT DOWNSTREAM OF PROSPECT TAILRACE
