Aesthetic Flow Assessment Study

West Canada Creek Hydroelectric Project

FERC No. 2701-NY

March 2020

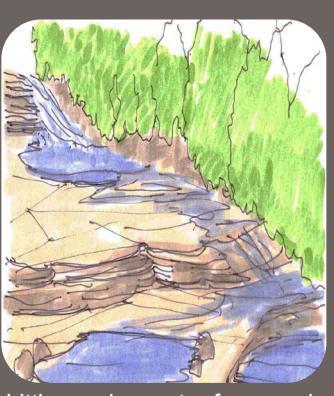
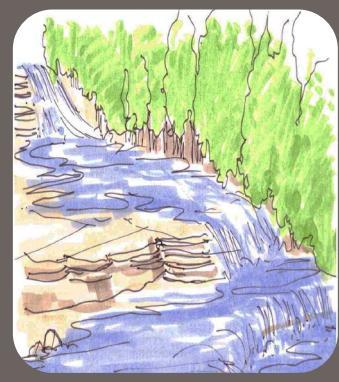
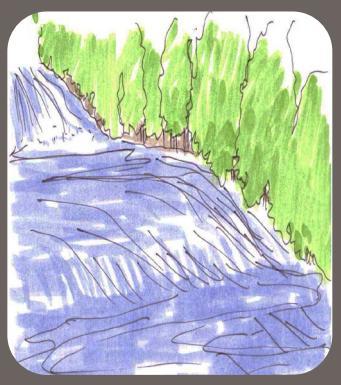
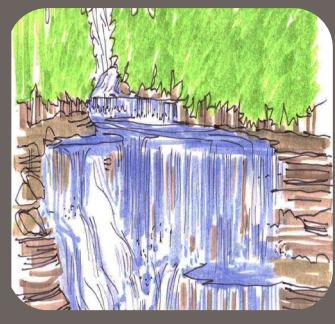
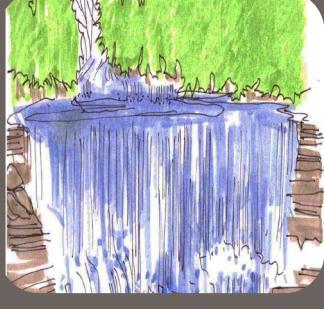
As part of the on-site assessment, rating panel members were provided example sketches of the different river and waterfall attributes that could be present during the releases. This was provided to convey a common understanding of terminology and a basis for discussion and rating of the different river conditions that could occur under various flows (see illustrations in Appendix B). EDR conducted photo and video documentation of the three selected flows at each selected KOP location (see photolog in Appendix D). For each bypass reach, the rating panel reviewed the KOP aesthetic view characteristics and individually completed an evaluation form during each controlled flow event.

Little moving water from pool to pool

Sequence of well-defined pools and riffles

Fast moving water with whitewater over rocks

Multiple cascades of water with some veiling and portions of cliff face visible

Continuous veil of falling water with no visible rock ledges or cliff face

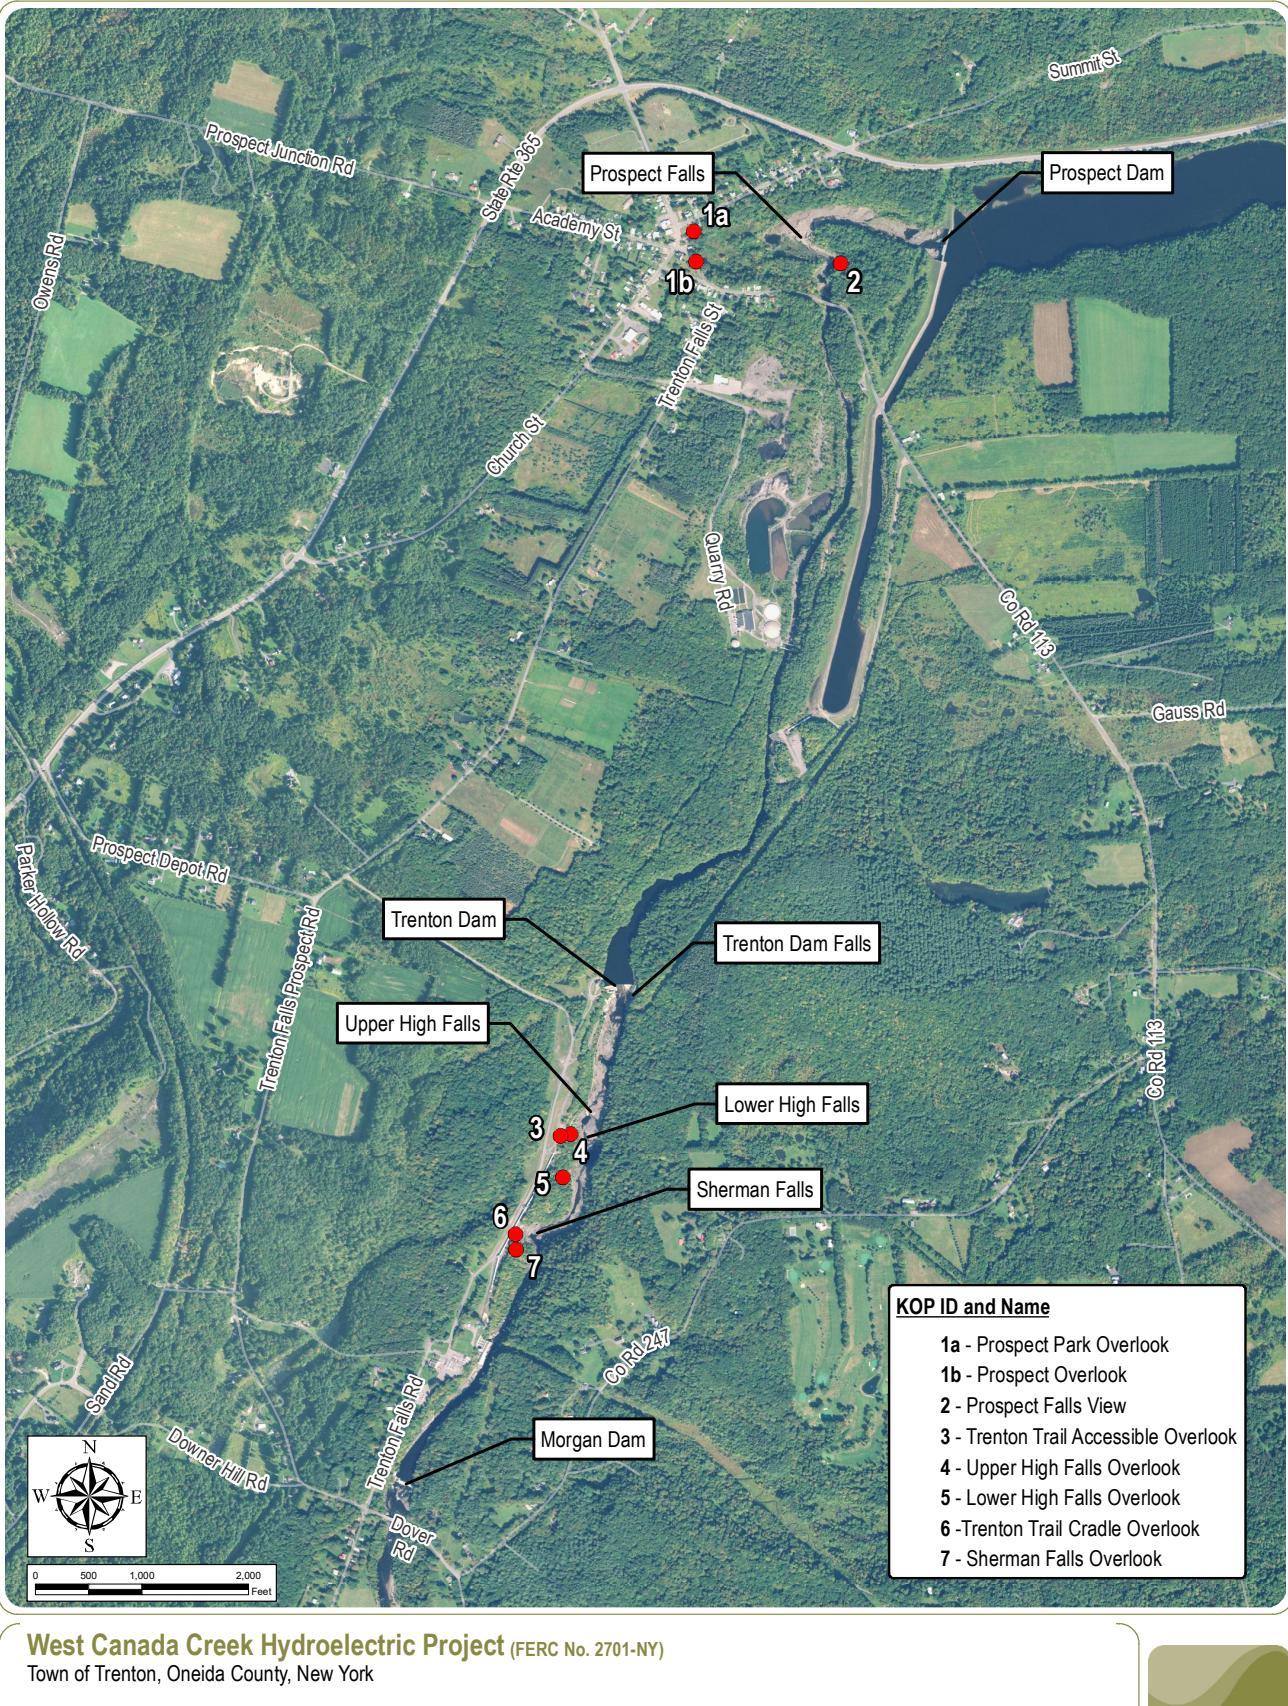
Figure 1 | Study Area with KOP Locations

The Project Study Area includes the Prospect and Trenton Falls bypass reaches on West Canada Creek (see Figure 1). Within this area, seven potential KOPs were identified for evaluation by Erie, five of which were ultimately chosen as locations for analysis of various flows. These include two sites with views of the Prospect bypass reach (KOPs 1b and 2) and three sites with views of the Trenton Falls bypass reach (KOPs 4, 5 and 7). These five final KOPs provide key views of notable waterfalls located within the Prospect and Trenton bypass reaches. See Section 2.3 for additional description of consultation pertaining to the selection of the KOPs, and Section 3.4 for descriptions of KOP locations and characteristics.

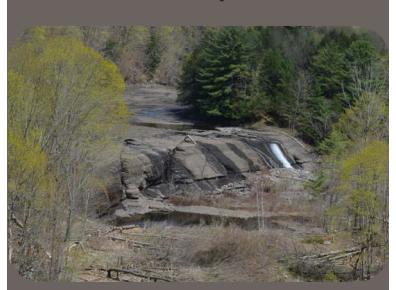
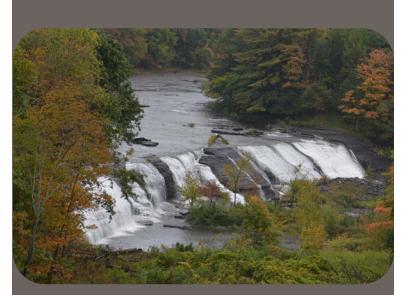
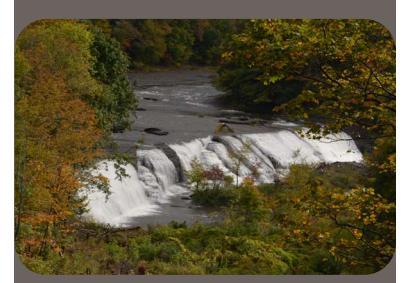
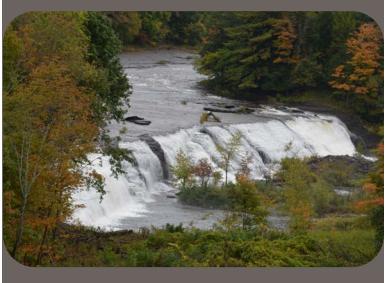
Prospect Overlook

No Release/Leakage

100 CFS

200 CFS

300 CFS

At 100 cfs, the most appealing individual attribute at KOP 1b was the sound generated by the waterfall (average score of 4.0) and the least appealing was the contrast between pools and moving water in the river channel (average score of 2.75). Positive attributes noted by the evaluators at 100 cfs included good sound volume and a good mix of exposed rock and veiling at the falls. Negative attributes at this flow level included too much exposed rock, limited whitewater/turbulence in the channel, and the water appearing to be spread too thin over the falls and shallow within the channel.

At 200 cfs, the most appealing attributes were the sound level and the amount of exposed rock/stream bed (average score of 4.1), and the least appealing was the contrast between pools and moving water (average score of 3.6). Positive attributes noted by the rating panel included better water coverage/veiling at the falls and more riffles/turbulence upstream. Negative attributes at this flow level included the amount of exposed rock, lack of visible pools, and limited complexity of the flowing river.

With the final evaluated flow of 300 cfs at KOP 1b, waterfall size/volume was the most appealing aesthetic attribute (average score of 4.7), while the least appealing remained the contrast between pools and moving water in the channel (average score of 3.8). Positive attributes noted by the rating panel included appealing riffles upstream, fuller coverage of the falls, more color to the water (reflecting greater depth), more mist/spray coming off the falls, more turbulence in the plunge pool below the falls, and louder sound. Negative attributes included reduced variation of water and less exposed rock at the falls, and continued shallow water depth upstream of the falls. It is worth noting that three of the evaluators did not indicate any negative attributes at the 300 cfs flow level.

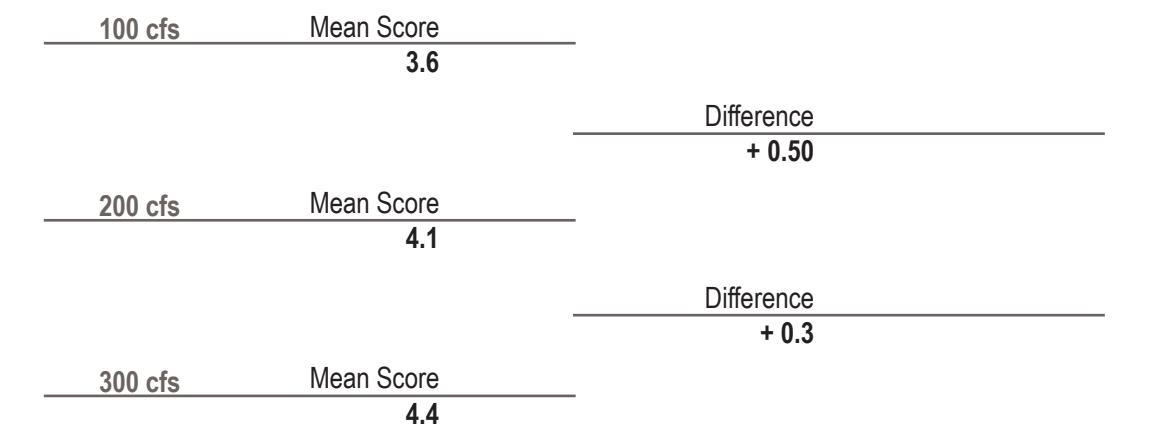
Commonly used attribute descriptions used by the rating panel members during the flow assessment.

100 cfs	Positive descriptions at 100 cfs: Sound (5), Veiling (4), Decent (2) Negative descriptions at 100 cfs: Lack of Turbulence (3), Thin (4), Limited Flow (2)
200 cfs	Positive descriptions at 200 cfs: Rock (4), Veiling (4), Sound (3), Riffle (3) Negative descriptions at 200 cfs: Rock Exposure (3)
300 cfs	Positive descriptions at 300 cfs: Riffle (3), Rock Face/Protrusion (3), Turbulence (2), Mist/ Spray (2), Color (2), Channels (2) Negative descriptions at 300 cfs: No Upstream/Above Falls Change (2), Minimal Rock Exposure (2)

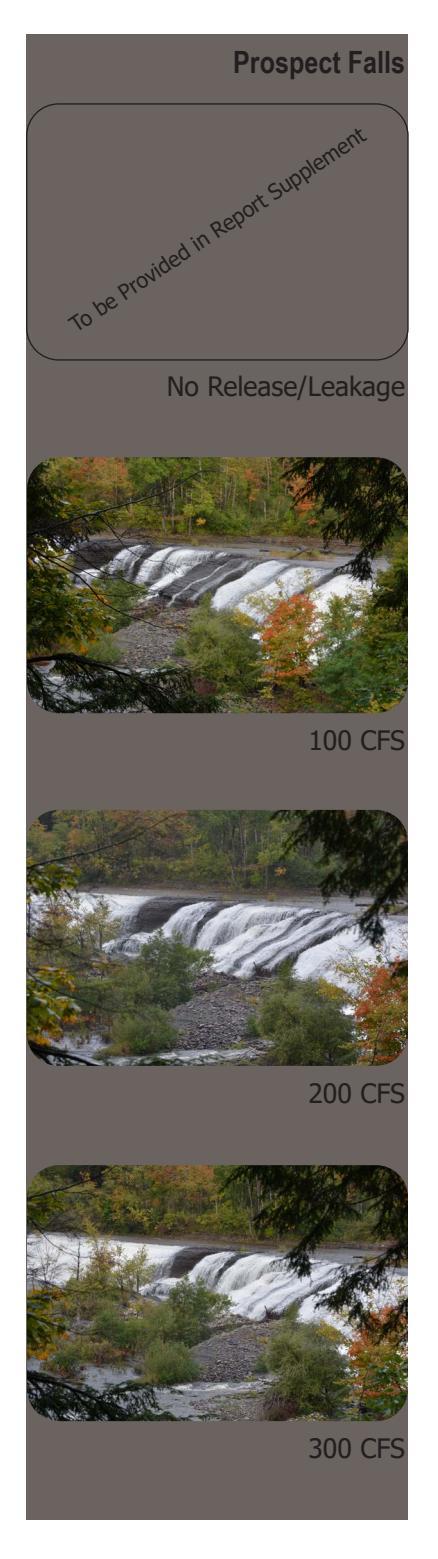
The individual attributes that experienced the greatest aesthetic improvement with increased flows at KOP 2 included the amount of turbulence, wetted channel width, and waterfall size/volume. Additional enhancements recommended by the panel at KOP 2 included some limited clearing of trees or branches at the overlook to provide wider open views of the river and formalizing public access to this site.

Below is the mean score for each flow release and the difference between levels.

At 100 cfs the most appealing attribute at KOP 2 was the sound generated by the falls (average score of 4.1) and the least appealing was the wetted channel width (average score of 2.8). Positive attributes noted by the rating panel at 100 cfs included good sound volume, decent contrast in turbulence, and variable levels of veiling over the falls. Negative attributes at this flow level included excessive exposed rock, limited interaction between pools and moving water, limited water depth over the falls, and areas of dry streambed along the edges of the channel.

With an increase to 200 cfs, the most appealing attribute remained the sound level (average score of 4.3) and the least appealing remained the wetted channel width (average score of 3.6). Positive attributes noted by the rating panel at 200 cfs included a good mix of exposed rock and veiling at the falls, more noticeable water volume and speed, more whitewater/riffles in the upstream and downstream channels, and a nice ratio of whitewater to pools. Negative attributes noted at this flow included exposed rock, submerged terrestrial vegetation in the downstream channel, and less interaction between whitewater and pools as the channel filled up.

With the final evaluated flow of 300 cfs, sound level remained the most appealing individual attribute (average score of 4.9), while the amount of pools/still water in the channel was the least appealing attribute (average score of 3.9). Positive attributes noted by the rating panel at this flow level included optimal veiling and generation of mist at the falls, more wetted width within the downstream channel, and increased turbulence and variation of river features. Negative attributes included a lack of well-defined pools and some remaining exposed rock at the falls.

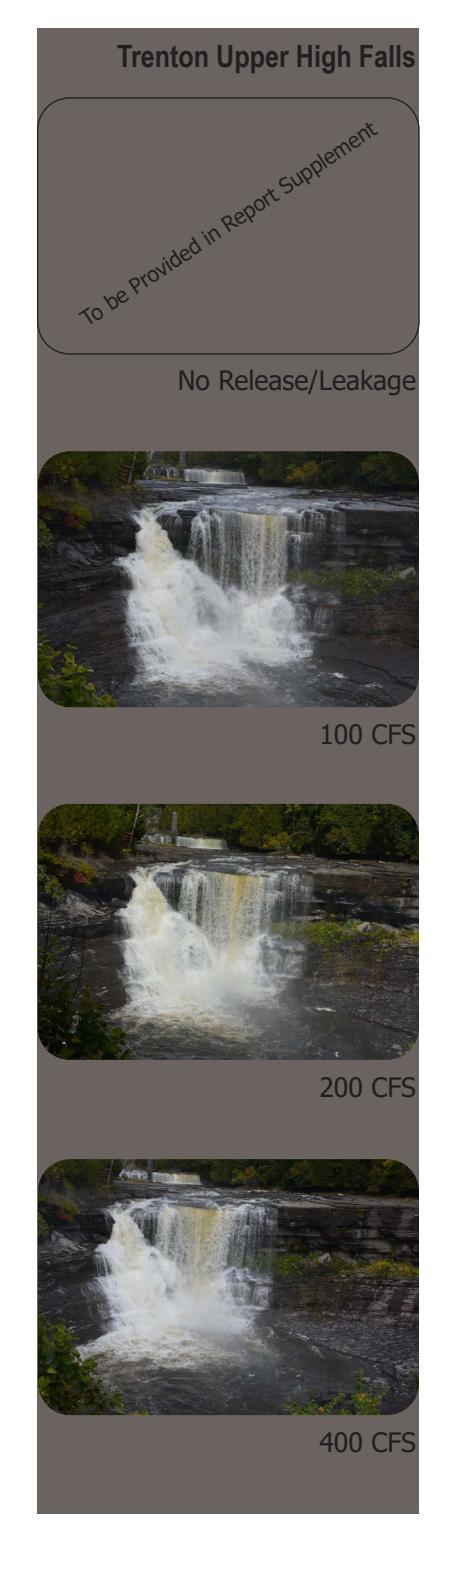
The individual attributes of the river that experienced the greatest aesthetic improvement with increased flows at KOP 4 included the wetted channel width, contrast between pools and moving water, and the amount of exposed rock at the falls. Additional enhancements recommended by the panel at KOP 4 focused on further increasing water flow. The rating panel liked the current quality of the overlook and noted the availability of access for a variety of users. Tree clearing and the addition of a viewing platform were mentioned as possible enhancements. It is noting that at both 200 cfs and 400 cfs half of the reviewers provided no recommendations for further aesthetic enhancements.

Below is the mean score for each flow release and the difference between levels.

At 100 cfs, the most appealing individual attribute at KOP 4 was the sound generated by the waterfall (average score of 4.0) and the least appealing was the wetted channel width (average score 2.6). Positive attributes noted by the evaluators at 100 cfs included good sound volume, nice veiling and spillover at the falls. Negative attributes at this flow level included too much exposed rock, with some evaluators noting the overall dryness and lack of water at the falls.

At 200 cfs, the most appealing attribute was again the sound of the falling water (average score of 4.4), and the least appealing attribute was the amount of pools/still water in the channel (average score of 3.4). Positive attributes noted by the rating panel included misting that could be seen and felt, better water veiling of the falls, and cascading flows. Negative attributes at this flow level again included the amount of exposed rock, with some evaluators noting a limited amount in change from the previous flow.

With the final evaluated flow of 400 cfs KOP 4, sound level continued to be the most appealing aesthetic attribute (average score of 4.9), while the least appealing was the contrast between pools and moving water in the channel (average score of 3.7). Positive attributes noted by the rating panel included clouds of mist rising from the falls and the series of small stepped falls with deep and wide cascading veils of water dropping into a plunge pool. Negative attributes included reduced variation of water movement, continued exposure of bare rock, and minimal overall change with the increase in water flow from 200 to 400 cfs.

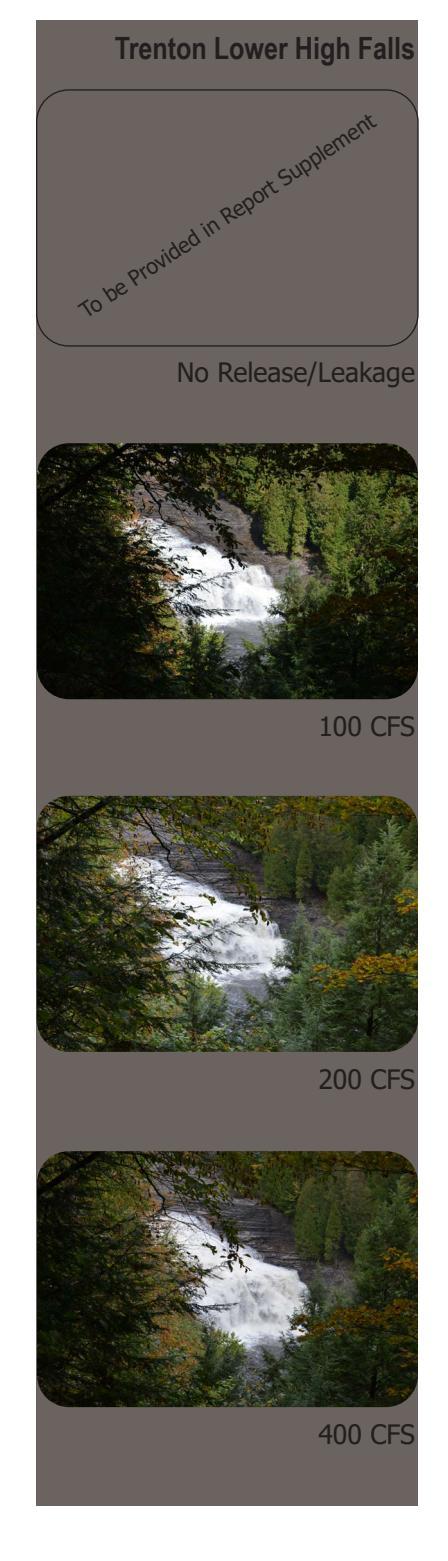
The individual attributes of the river that experienced the greatest aesthetic improvement with increased flows at KOP 5 included the amount of turbulence, wetted channel width, and waterfall size and volume. Additional enhancements recommended by the panel at KOP 5 centered on remedying the narrowness of the viewing window. Tree clearing and trimming of branches were recommended as a means of enhancing the view. However, some of the reviewers were careful to specify judicious clearing or pruning and not clear-cutting, noting value in the secluded, heavily forested setting.

Below is the mean score for each flow release and the difference between levels.

At 100 cfs, the most appealing individual attribute at KOP 5 was the sound generated by the waterfall (average score of 4.0) and the least appealing was the amount of pools or still water in the channel (average score of 3.1). Positive attributes noted by the evaluators at 100 cfs focused on the amount of exposed rock at the falls, as well as the amount of water going over the falls, including thick veiling and cascading. Good sound from the falls was also mentioned. Negative attributes focused less on the flow level than the restricted viewing window. Reducing the amount of exposed bedrock, a desire for higher flow, and the need for tree clearing were mentioned as possible improvements.

At 200 cfs, the most appealing attribute continued to be the sound level generated by the falling water (average score of 4.5), and the least appealing attribute was the contrast between pools and moving water (average score of 3.3). Positive attributes noted by the rating panel included the quality and volume of sound, deeper pools resulting in darker water, and the presence of active or turbulent water. Negative attributes at this flow level continued to focus on the narrow, restricted view with exposed bedrock. It is also noteworthy that three of the evaluators provided no negative comments with two replying "none" or "N/A."

With the final evaluated flow of 400 cfs, sound level maintained its position as the most appealing aesthetic attribute (average score of 4.7). Similarly, the least appealing attribute remained the contrast between pools and moving water in the channel (average score 3.5). Positive attributes noted by the rating panel related to the sound and movement of the water with descriptive adjectives such as "thundering", "gushing", and "dynamic" used. Negative attributes again focused on the narrowness of the viewing window and a minimal perceived change from the previous flow. Loss of contrast due to deeper water was also mentioned.

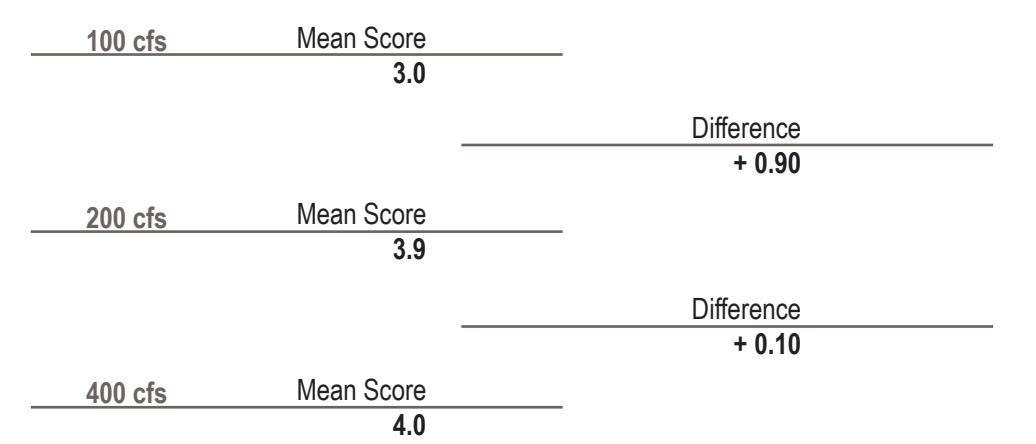
Commonly used attribute descriptions used by the rating panel members during the flow assessment.

100 cfs	Positive descriptions at 100 cfs:
	Crashing Sound (6),
	Negative descriptions at 100 cfs:
	Lack of Wetted/Covered Channel (3)
200 cfs	Positive descriptions at 200 cfs:
	Wetted Width (4), Turbulent (3), Sheeting (2), Sound/
	Volume
	Negative descriptions at 200 cfs:
	Exposed Rock/Bedrock (2), Loss of Detail/Features (2)
400 cfs	Positive descriptions at 400 cfs:
	Veil (3), Wetted Channel (3), Cascading (2), Upper Step (2),
	Sheeting/Sheet Flow (2)
	Negative descriptions at 400 cfs:
	No Common Descriptions

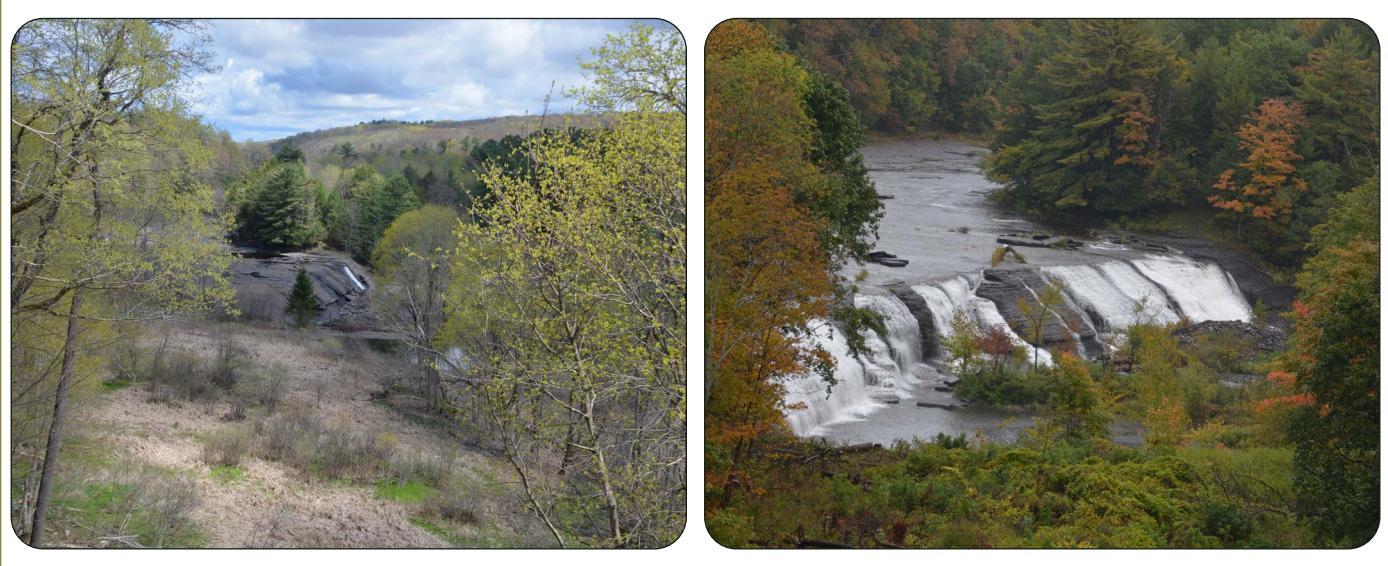
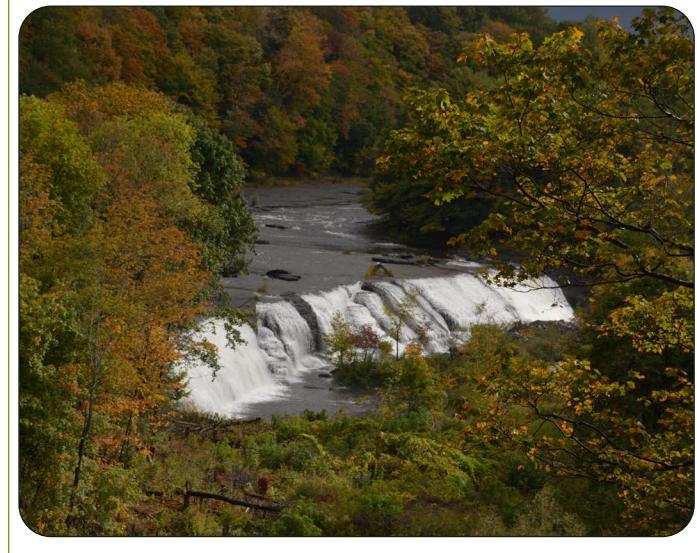
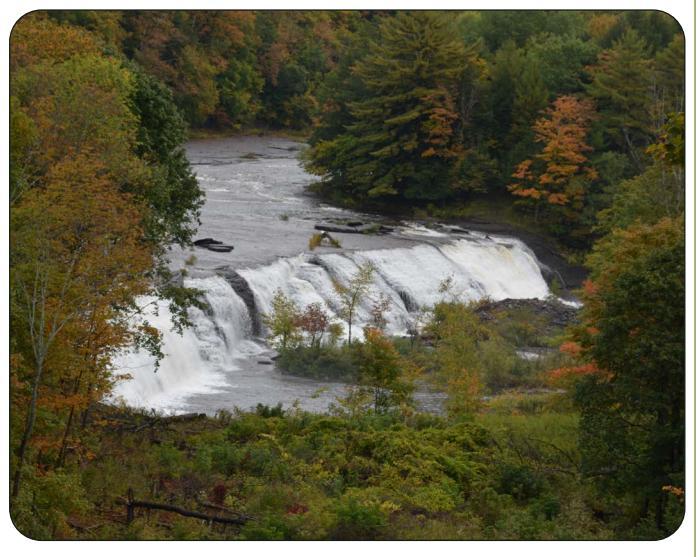
Prospect Development KOP 1b - Prospect Falls Overlook

No Release/Leakage

Target release rate 100 cfs

Target release rate 200 cfs

Target release rate 300 cfs

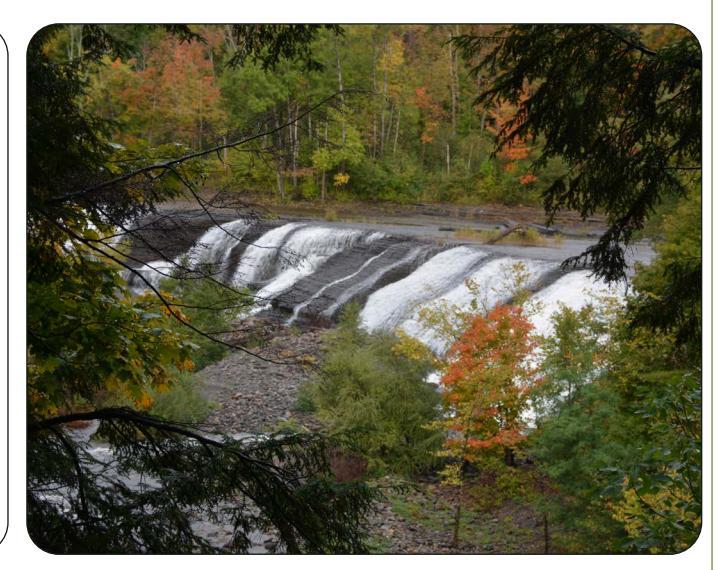
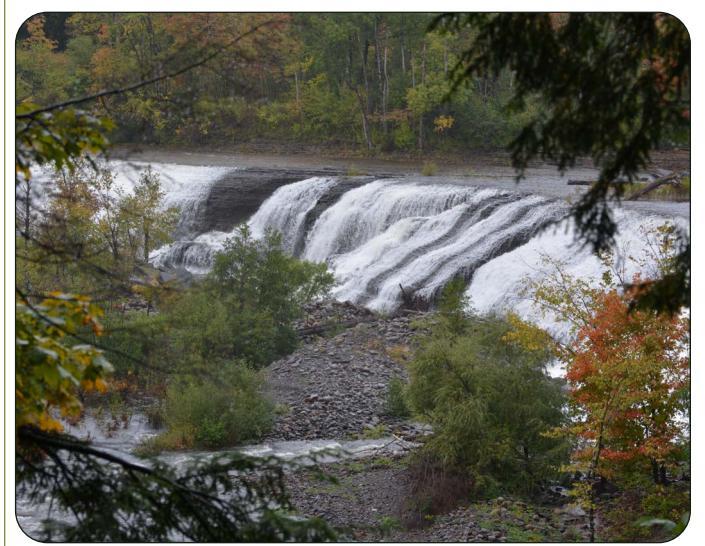
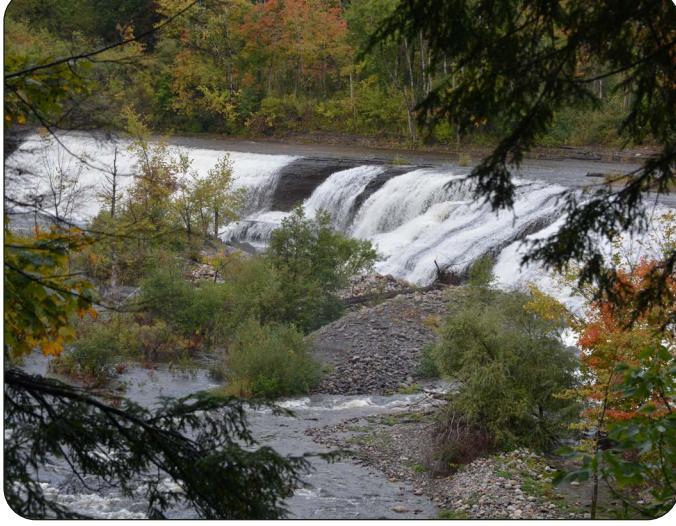
Prospect Development KOP 2 - Prospect Falls (Undeveloped Location)

No Release/Leakage

Target release rate 100 cfs

Target release rate 200 cfs

Target release rate 300 cfs

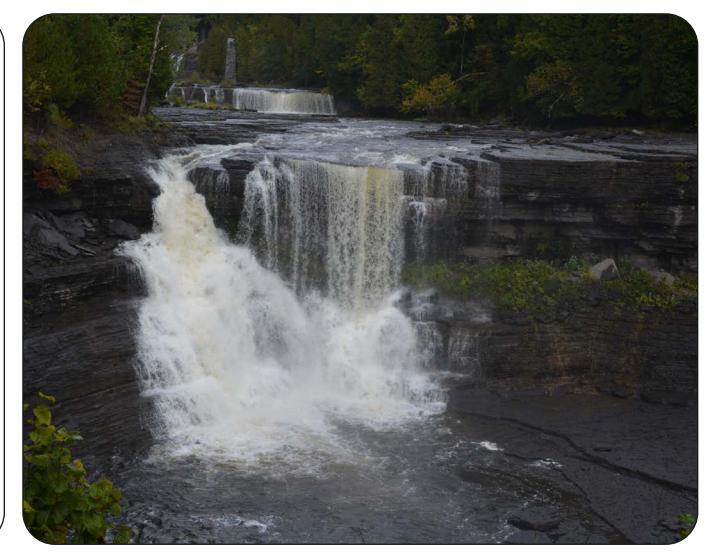
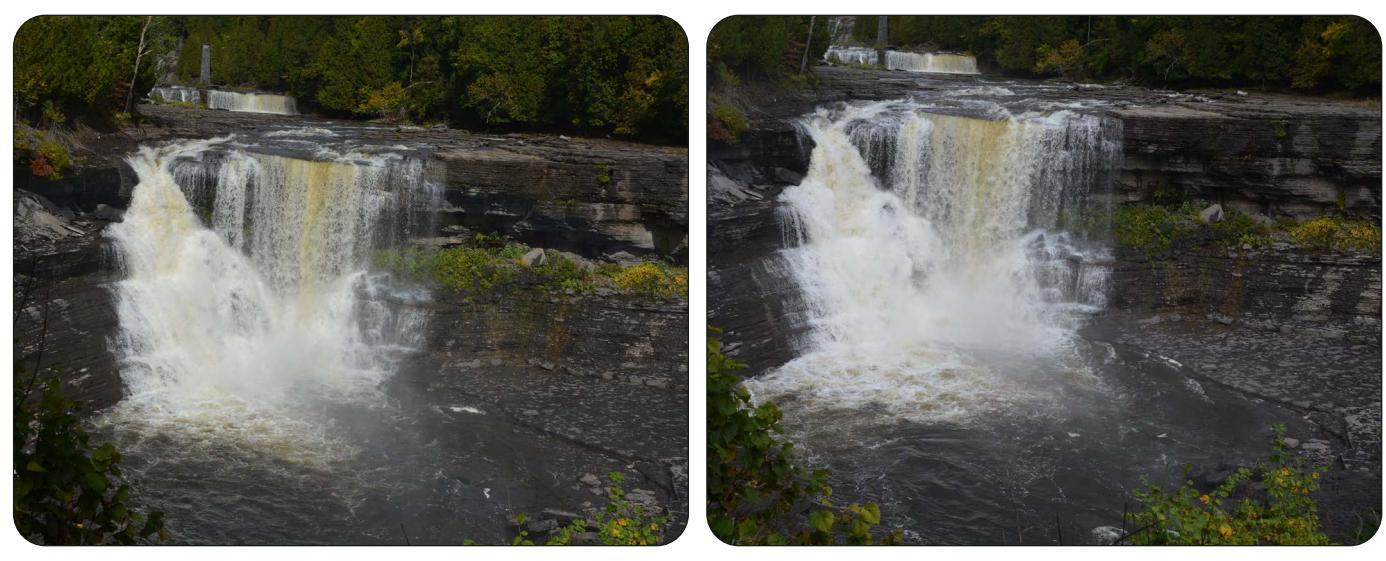
Trenton Development KOP 4 - Upper High Falls Overlook

No Release/Leakage

Target release rate 100 cfs

Target release rate 200 cfs

Target release rate 400 cfs
